**BASSLINK INTEGRATED IMPACT ASSESSMENT  
STATEMENT**

**POTENTIAL EFFECTS OF CHANGES TO HYDRO POWER  
GENERATION**

**APPENDIX 6:**

**GORDON RIVER RIPARIAN VEGETATION ASSESSMENT**

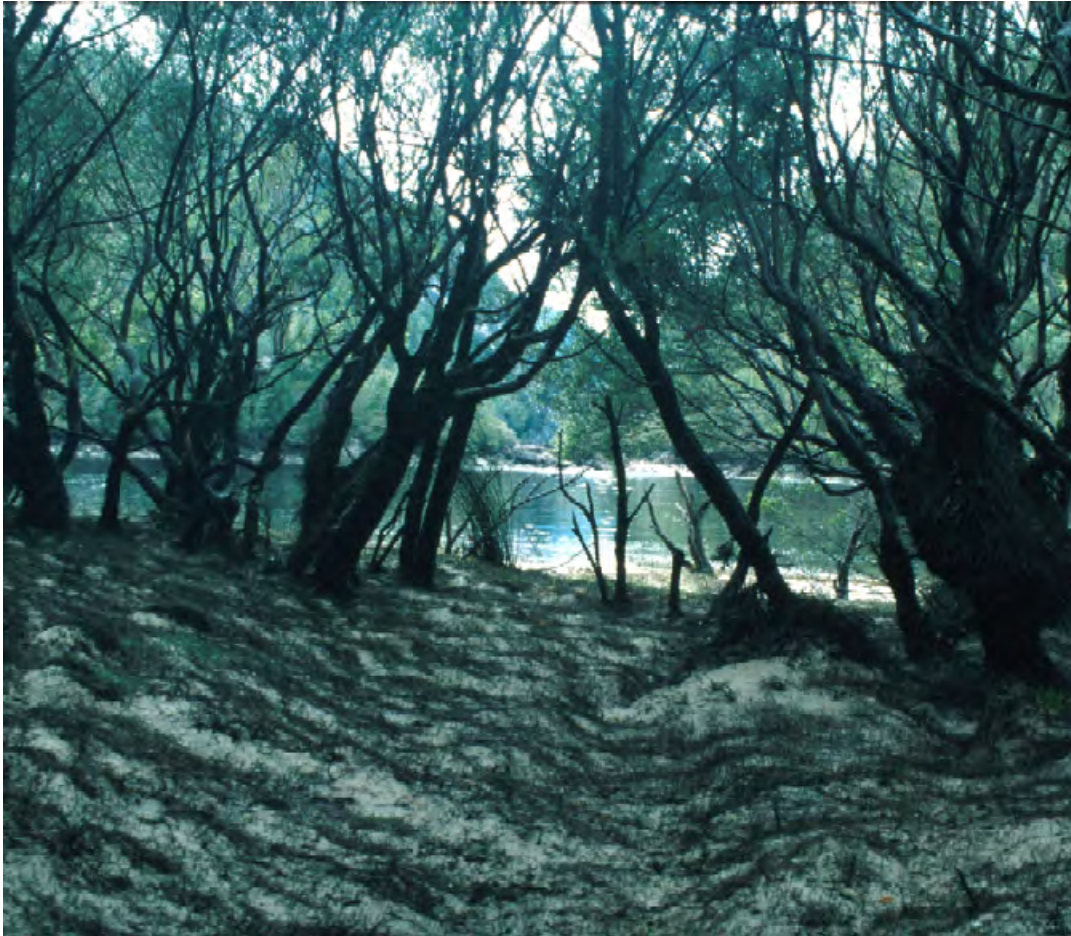
**Plate 1 cover photo:** *Leptospermum riparium* on an island at the bottom of Abel Gorge in the Gordon River (Site 70), 7.4 km below the Gordon dam, looking across a big pool to Abel Gorge. Note: there is no understorey vegetation, tree roots are exposed and leaves are absent from the trunks of the shrubs to height of approximately 2.5 m.

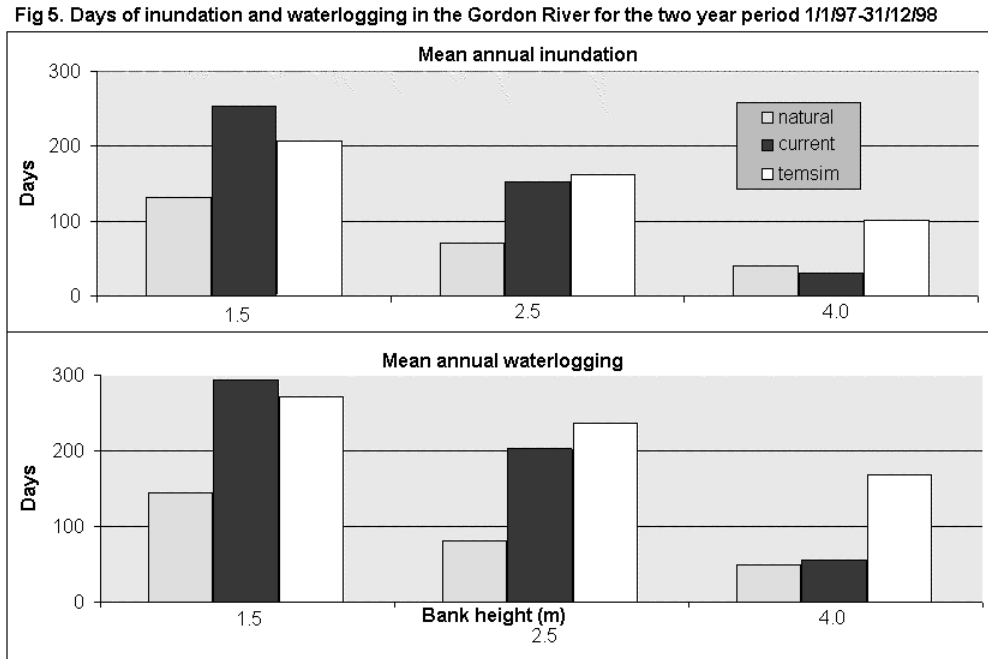
**Figure 5.** Mean annual inundation and b) mean annual waterlogging calculated from hourly flow (cumecs) for the period 1/1/97-1/1/99 at Site 72 (9.1 km down stream from the dam) for current power station operation, power station operation under Basslink simulated using TEMSIM 450 MW and natural flow simulated from rainfall records by summing total hourly records of flows >70 cumecs (1.5 m), flows >140 cumecs (2.5 m) and >210 cumecs (4.0 m), to give duration of stress at each of the bank heights 1.5, 2,5 and 4.0 m at Site 72.

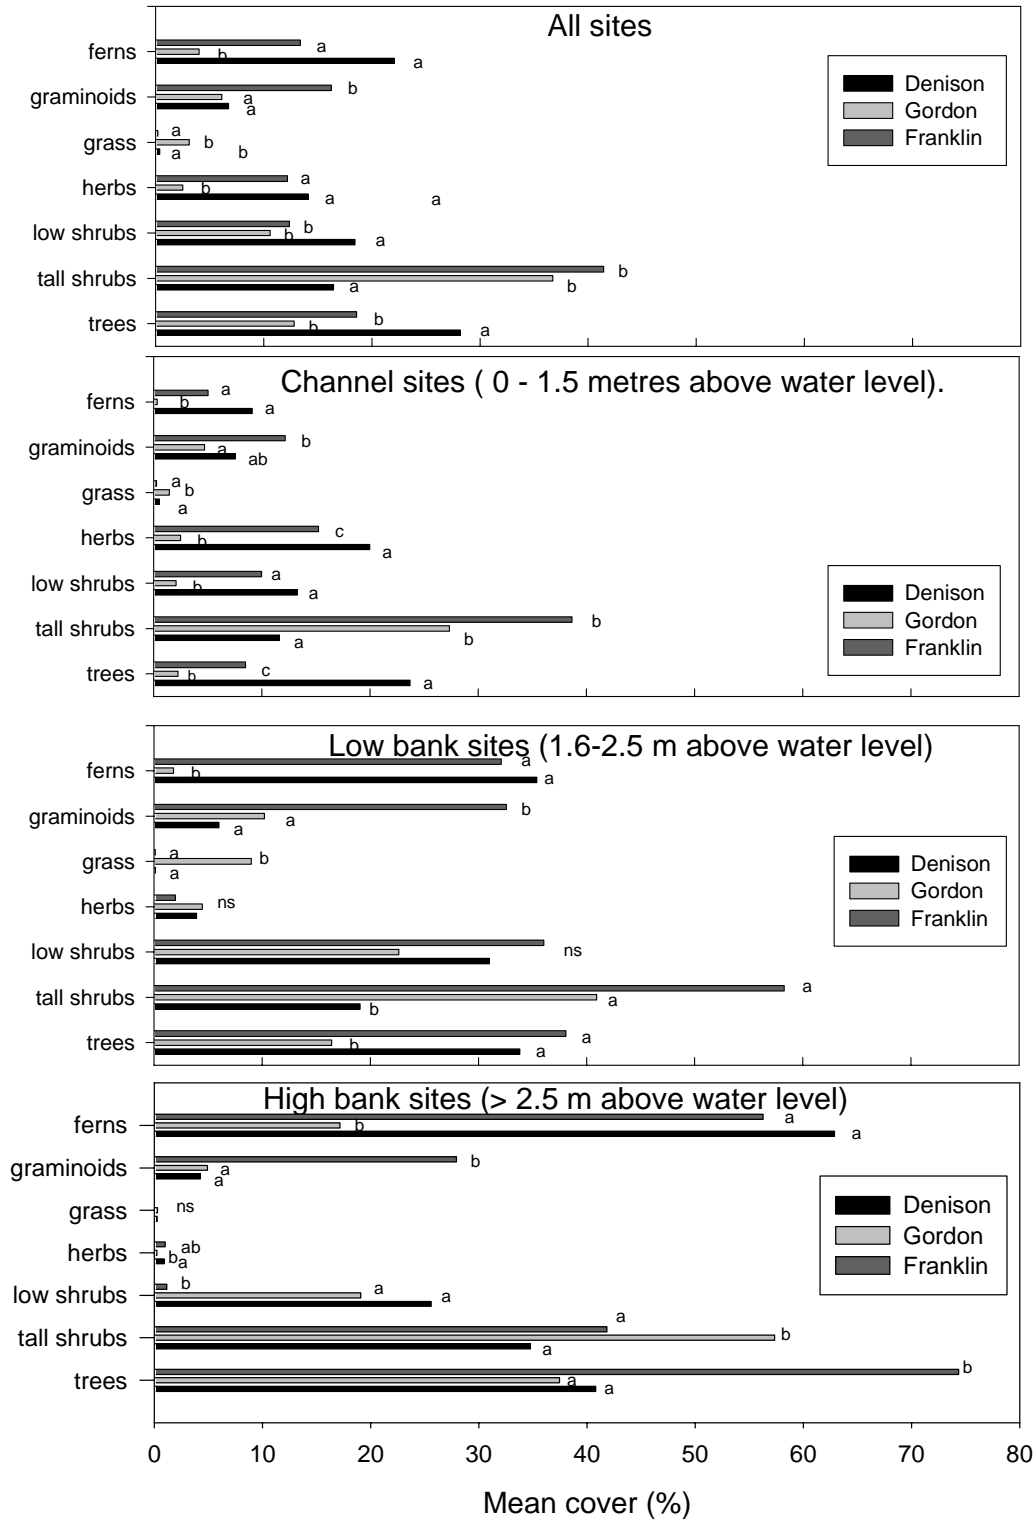
**Figure 11:** Mean percentage cover of vegetation guilds at all sites and data partitioned into zones: 0-1.5 m, 1.6-2.5 m and > 2.5 m on the river bank for the Denison, Gordon and Franklin rivers. Different letters indicate a significant difference between rivers at the P < 0.05 level, ns = not significant.

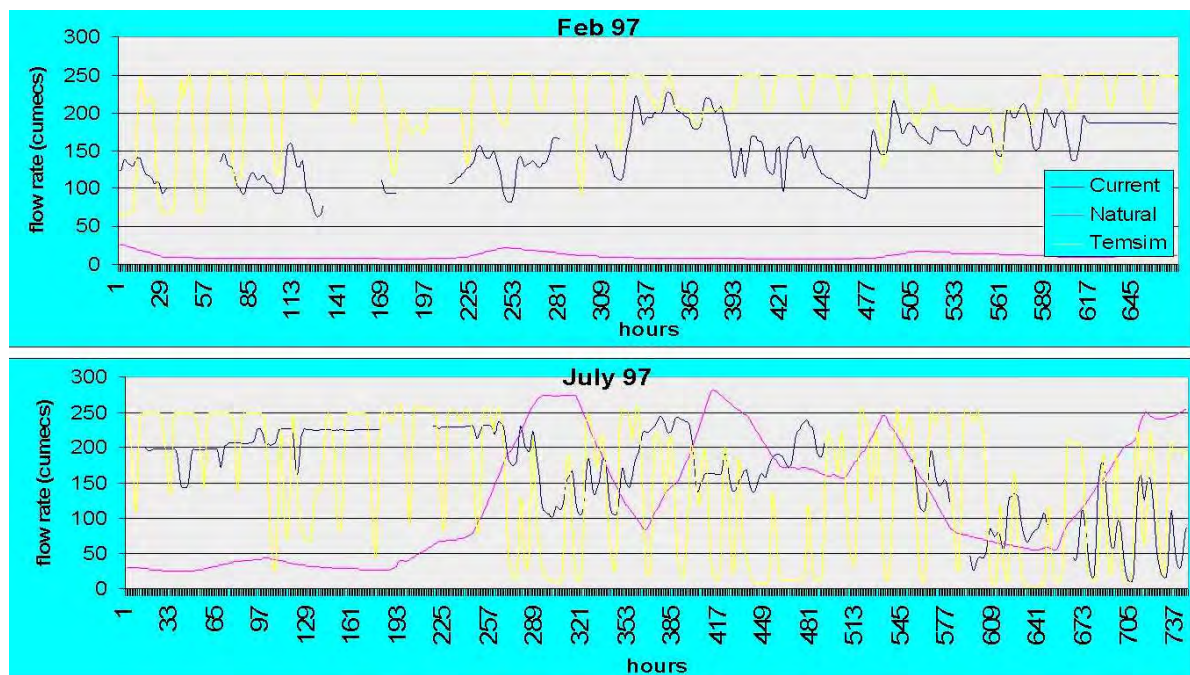
**Figure 15.** Hourly flow ( $\text{m}^3\text{s}^{-1}$ ) at Site 72 (9.1 km down stream from the dam) for current power station operation, for power station operation under Basslink simulated using TEMSIM 450 MW and natural flow simulated from rainfall records, for a) February 1997 and b) July 1997.

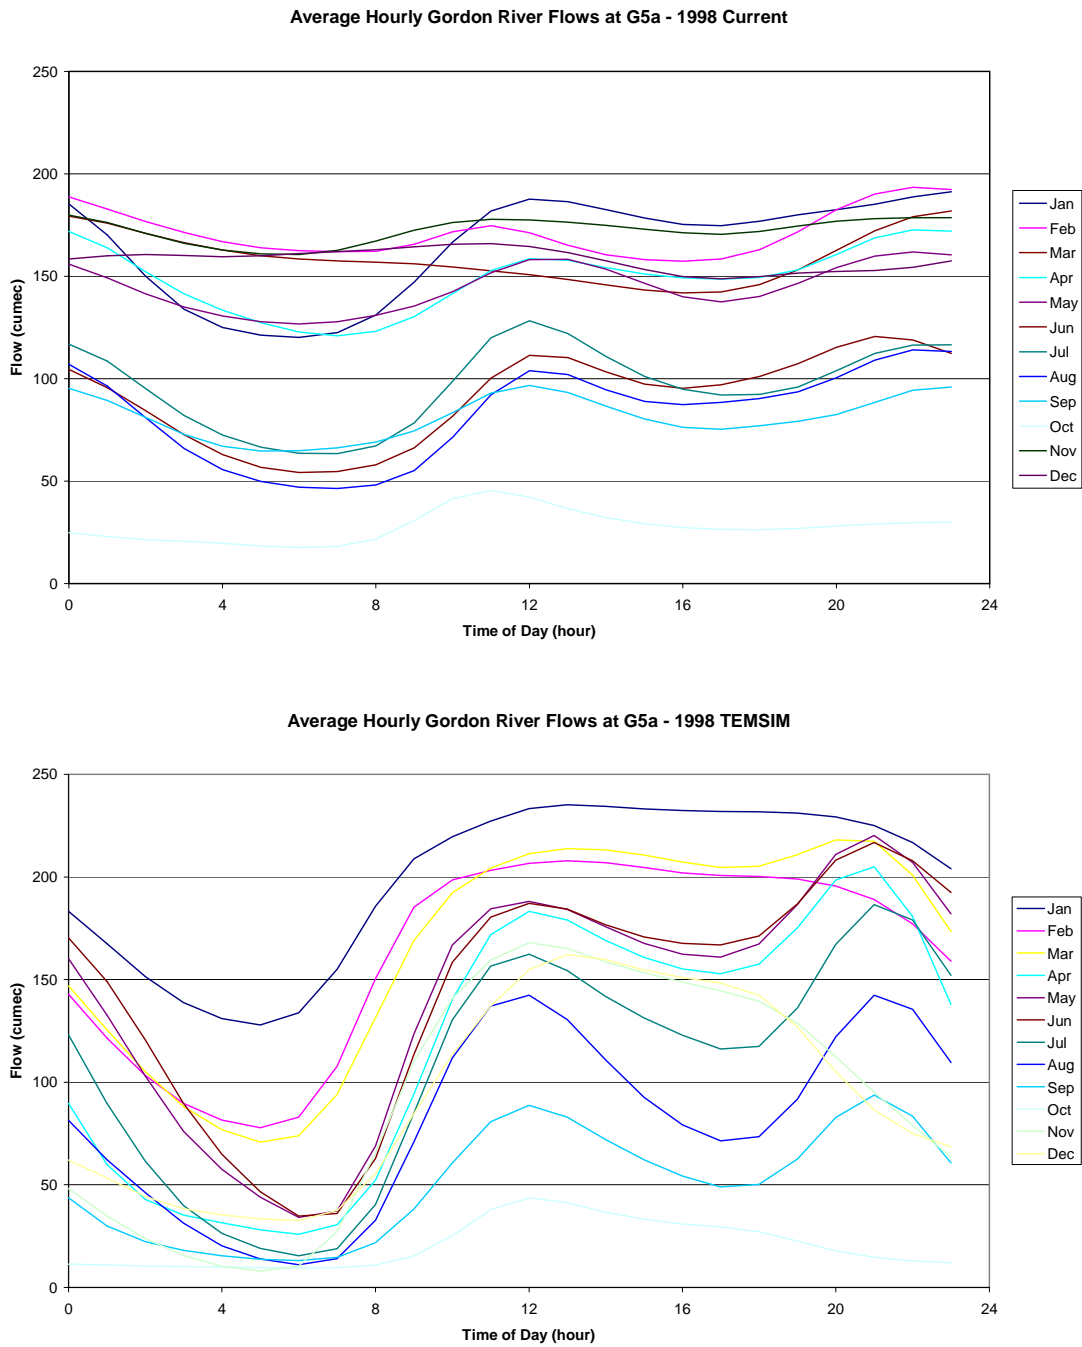
**Figure 16.** Average hourly Gordon River flows at Site 71 for each month during 1998 a) for the current regime and b) and Basslink modelled under TEMSIM 450 MW.

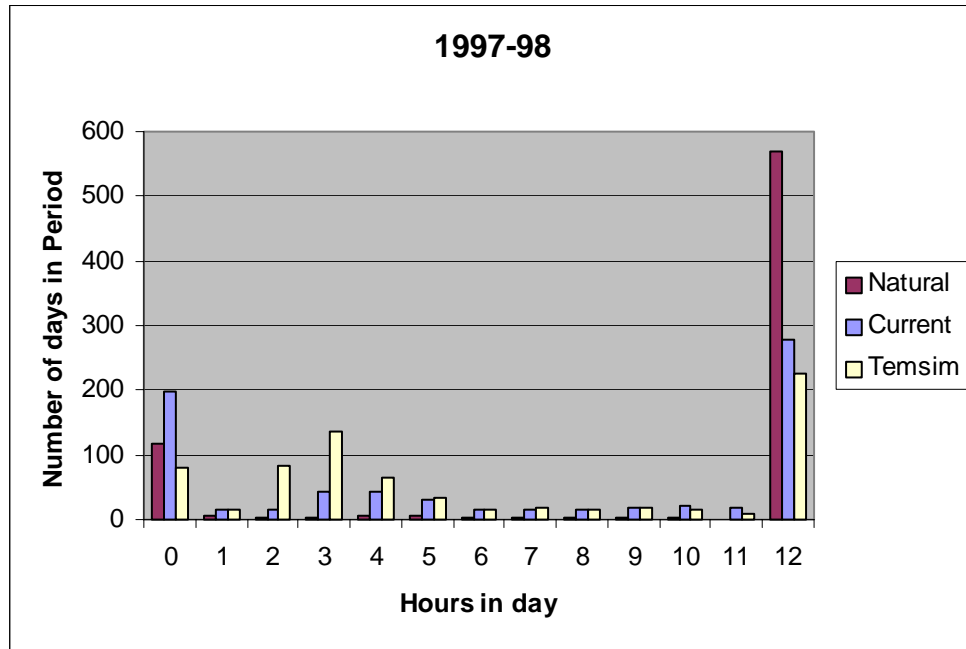
**Figure 17.** The average number of days per year (during 1997 and 1998) that plants at Site 72 (9.1 km from the dam), at a height of 2.5 m on the river bank (equivalent to flow rates of 140 cumecs), were free from inundation and able to carry out photosynthesis for 0, 1, 2, 3, 4, 5, 6, 7, 8, 9, 10, 11 and 12 daylight hours, under the current regime (Current), Basslink modelled using TEMSIM 450 (TEMSIM) and natural flow simulated from rainfall records (Natural). A uniform 12 hours of daylight was assumed to be available each day if plants were not submerged.

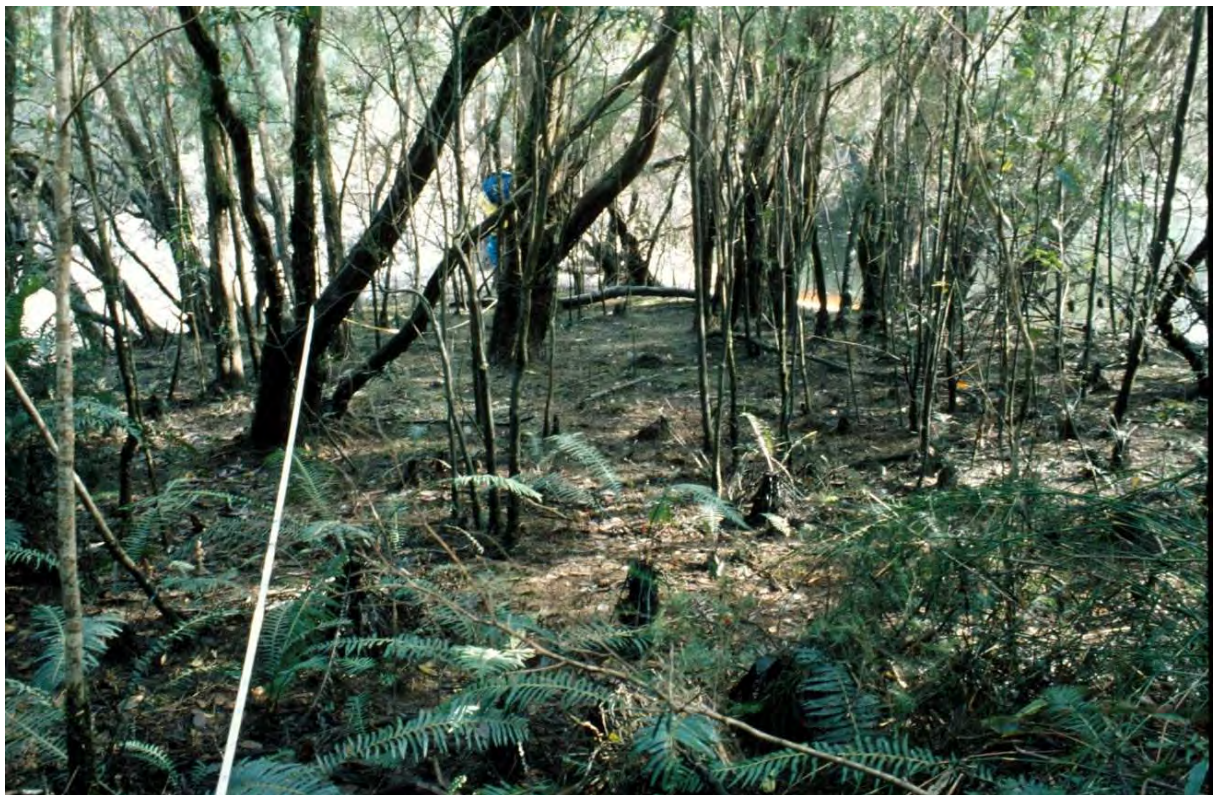
**Plate 8: View from the plimsoll line at 2.5 m on sandy river bank to the Gordon River 10.5 km below the dam.**

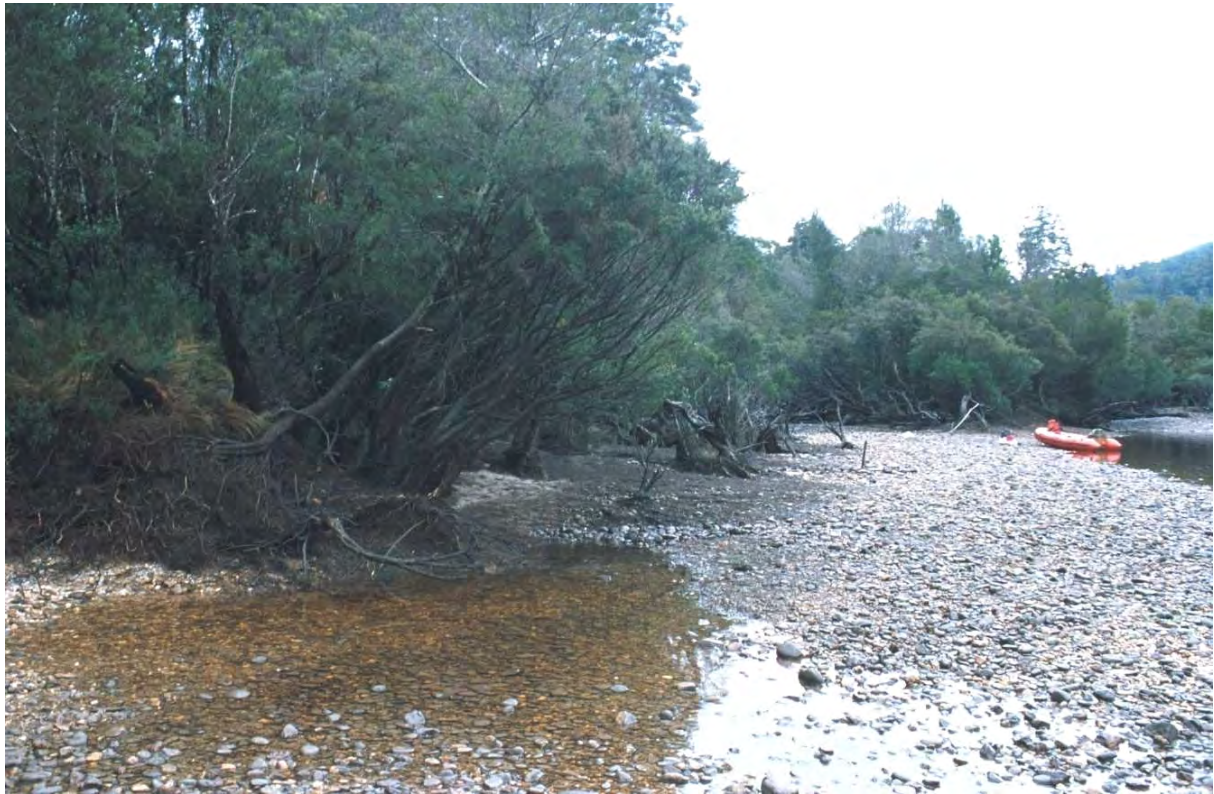
**Plate 10:** Vegetated rock island immediately below First Split showing the plimsoll line at approximately 2 m.

The operation of two turbines in the Gordon River has produced an obvious plimsoll-line in the riparian vegetation at approximately 2.5 m (manifest as a line in the trees and shrubs below which there are no leaves) from Abel Gorge to Second Split (7.4 to 12.0 km below the Gordon dam, Plates 7 and 8). The major constriction at the Second Split causes ponding and a plimsoll-line rises to approximately 3.5 m on the riverbank (Plates 9). Below the First Split the channel becomes broader and the plimsoll-line falls to approximately 2.0 m on the riverbank (Plate 6). The plimsoll-line continues beyond the junction with the Denison River and was obvious at about 2.0 m on the bank at the start of Ewarts Gorge (Harrison Creek, 23.3 km below the Gordon dam). Broadening of the river channel and modification to flow provided by natural tributaries results in a progressively less marked plimsoll line lower on the river bank with distance down the Gordon River (Plate 10).

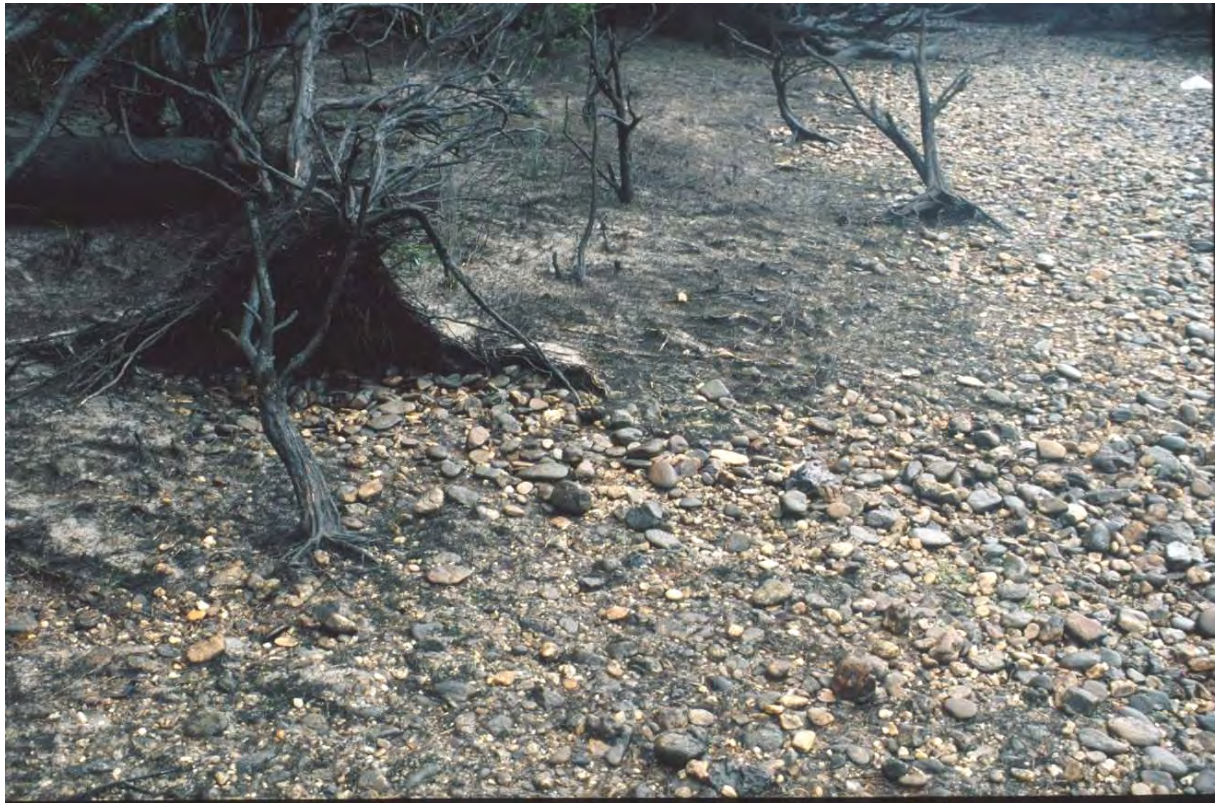
**Plate 11: *Leptospermum riparium* dominated riparian vegetation on an island at base of Abel Gorge in the Gordon River, 7.4 km below the Gordon dam, showing zones:-**

**0-1.5 m - comprised of mineral substrate and bare roots**

**2.5 m – a plimsoll-line**

**>2.5 m – surviving canopies of *L. riparium***

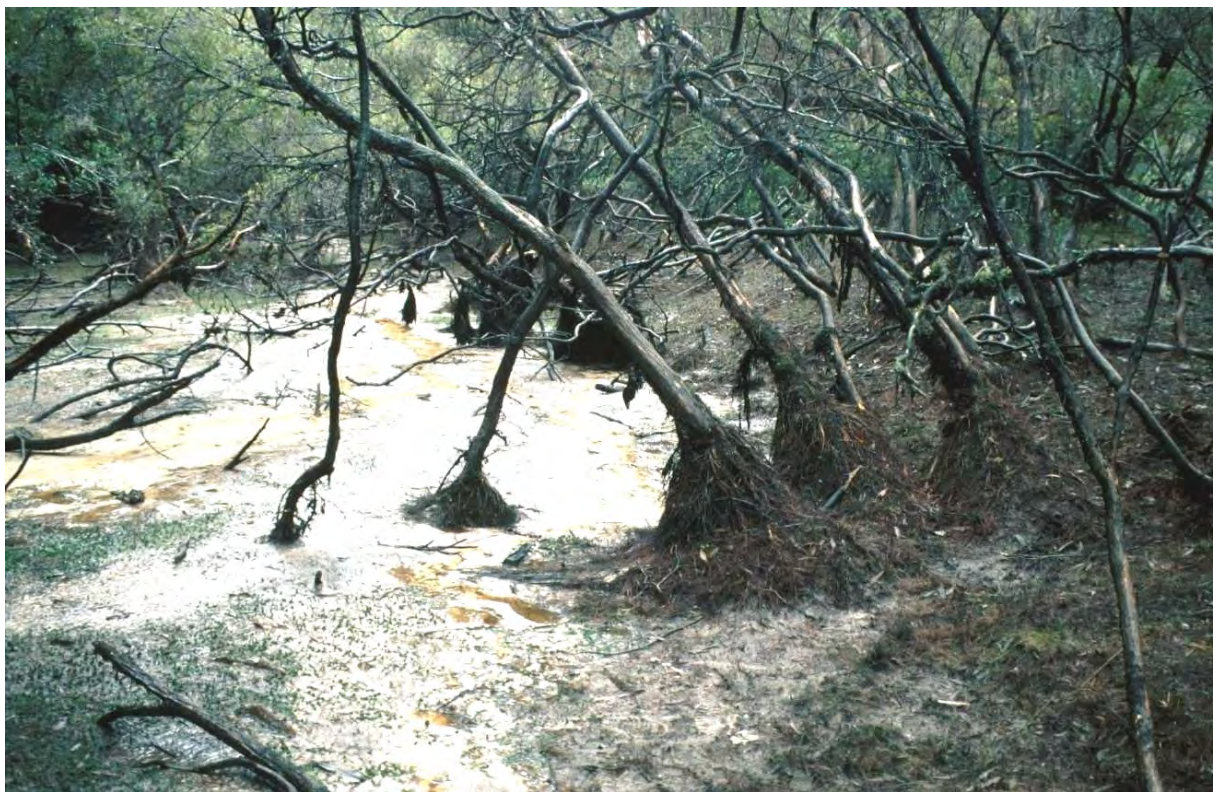
**Plate 12:** Mineral substrate, bare roots and dead stems of *Leptospermum riparium* in zone 0-1.5 m in the riparian vegetation on an island in the Gordon River, 7.4 km below the Gordon dam.

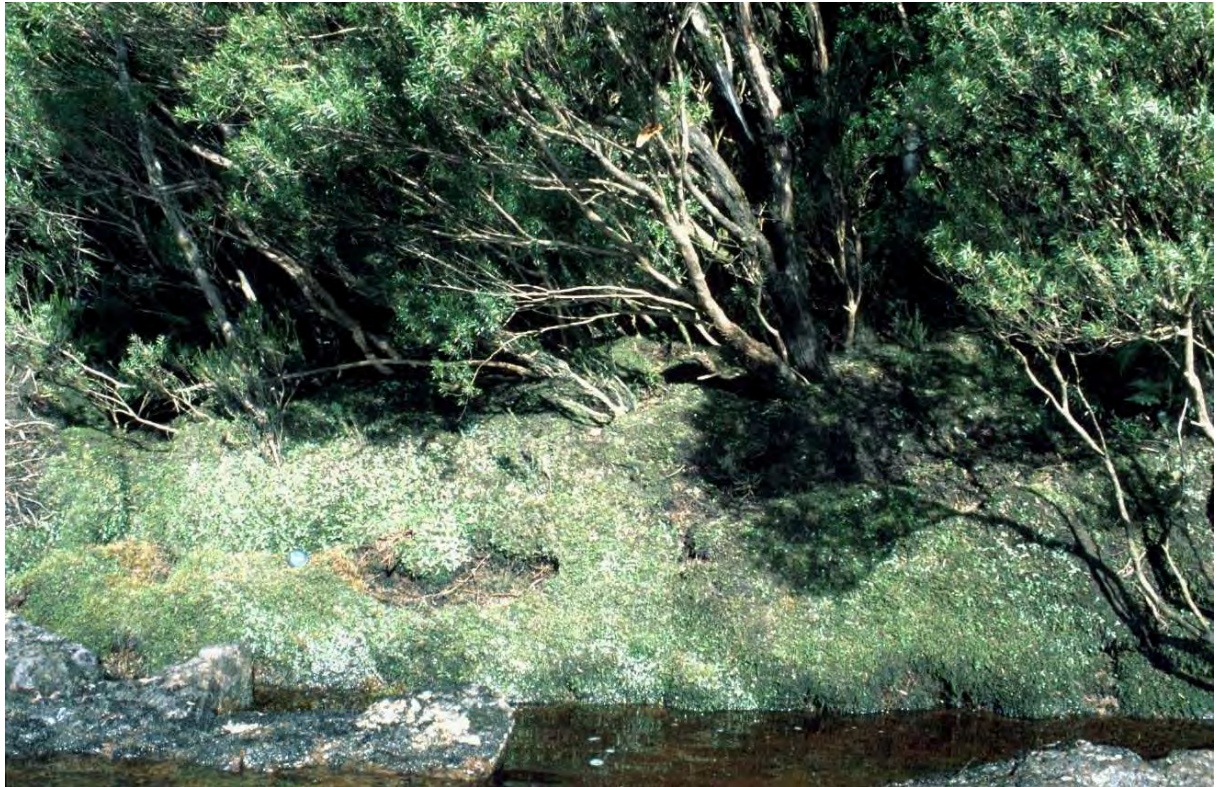
**Plate 17: Loss of riparian plants below the plimsoll line on silty substrate where a tributary creek meets the Gordon River 10.5 km below the dam. Waterlogging is most severe on fine textured substrates and may result in the death of *Leptospermum riparium*.**

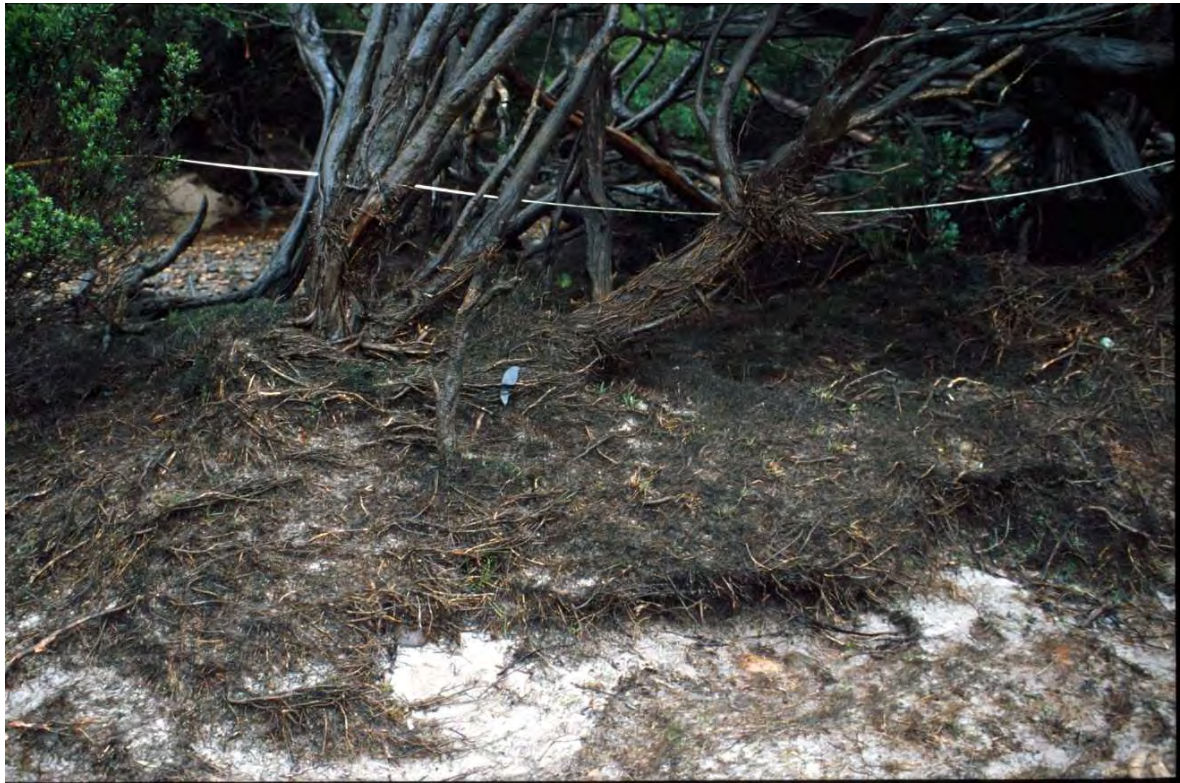
**Plate 22: Inundation and waterlogging in the Gordon River has killed many mosses and much of the epiphytic flora which grows on the trunks of trees at 2.5 m on the river bank exposing masses of adventitious roots which grow in the sand and silt trapped by these epiphytic communities.**

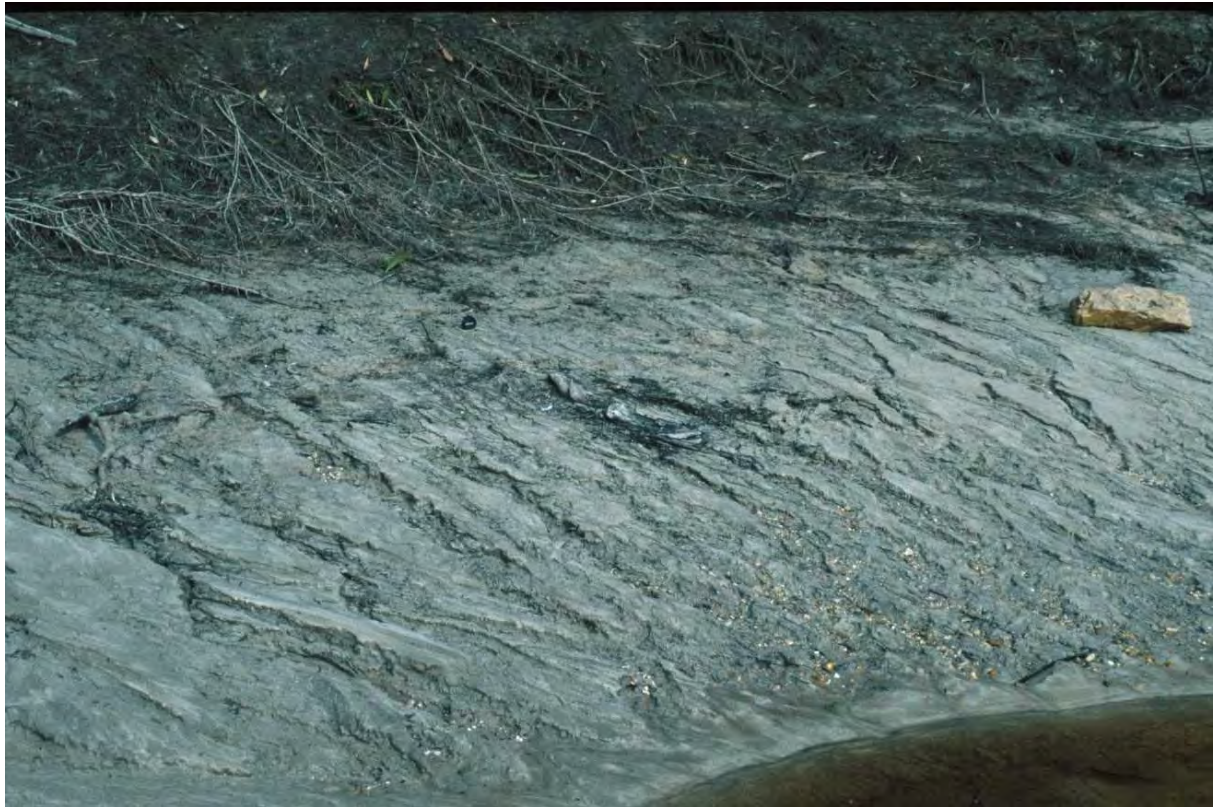
**Plate 24: Outflow of sediments from beneath the peat and root mats of vegetation on an island at the bottom of Abel Gorge in the Gordon River, 7.4 km below the Gordon dam.**

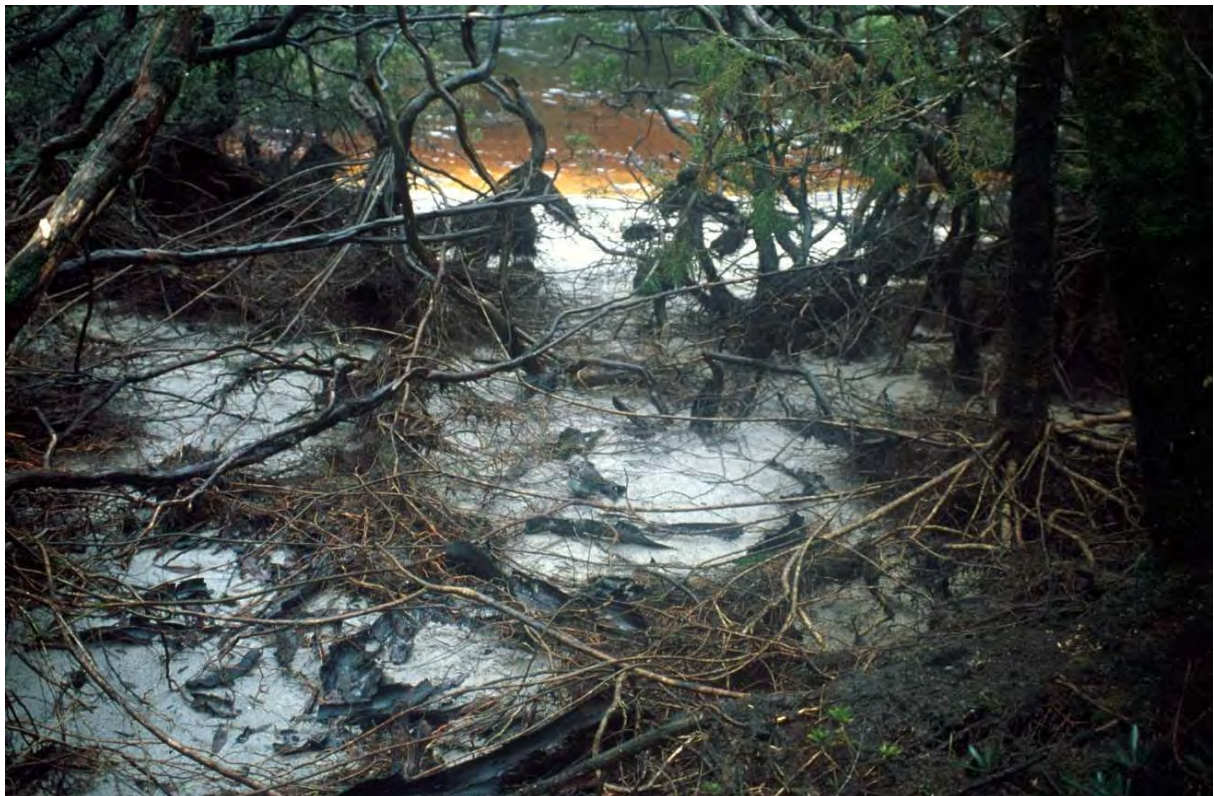
**Plate 25: Rilling in a sandbank below the root systems of *Leptospermum riparium* on an island at the bottom of Abel Gorge in the Gordon River, 7.4 km below the Gordon dam.**

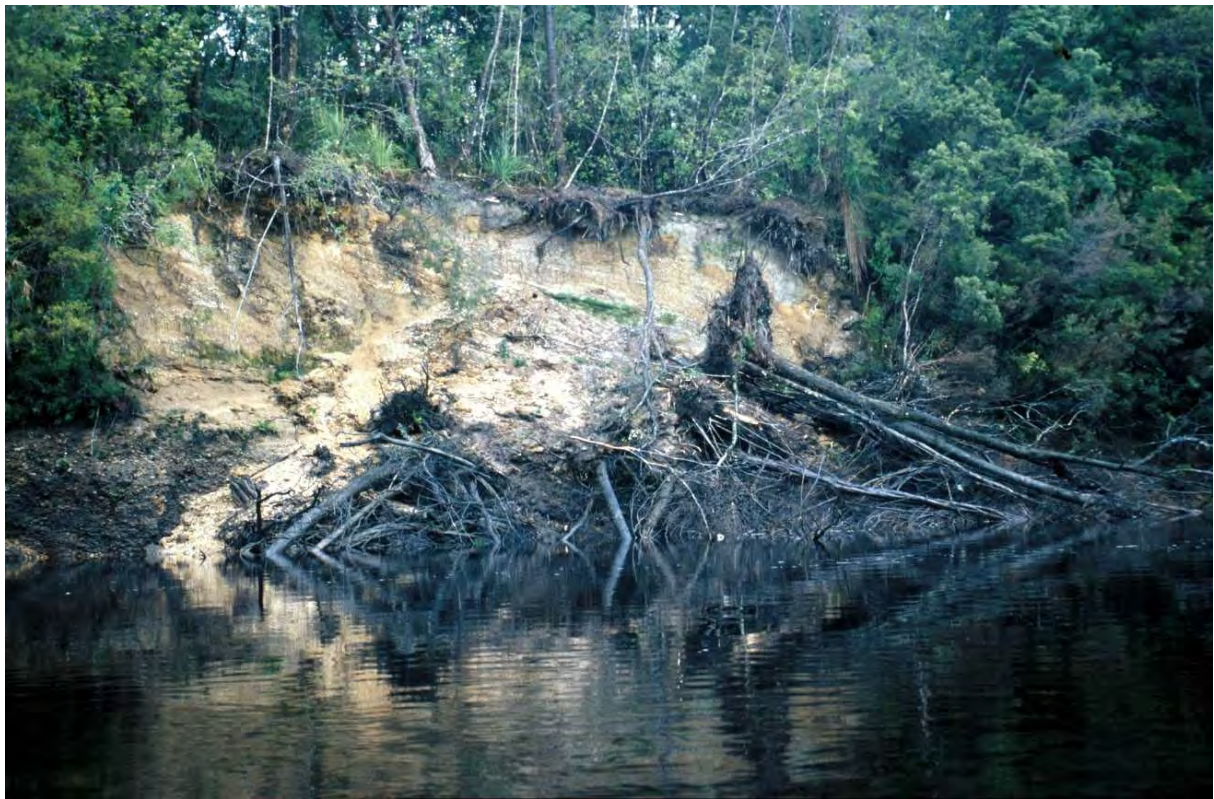
**Plate 26: The undermining of roots of riparian vegetation by outflow of sediments on an island at the bottom of Abel Gorge in the Gordon River, 7.4 km below the Gordon dam.**

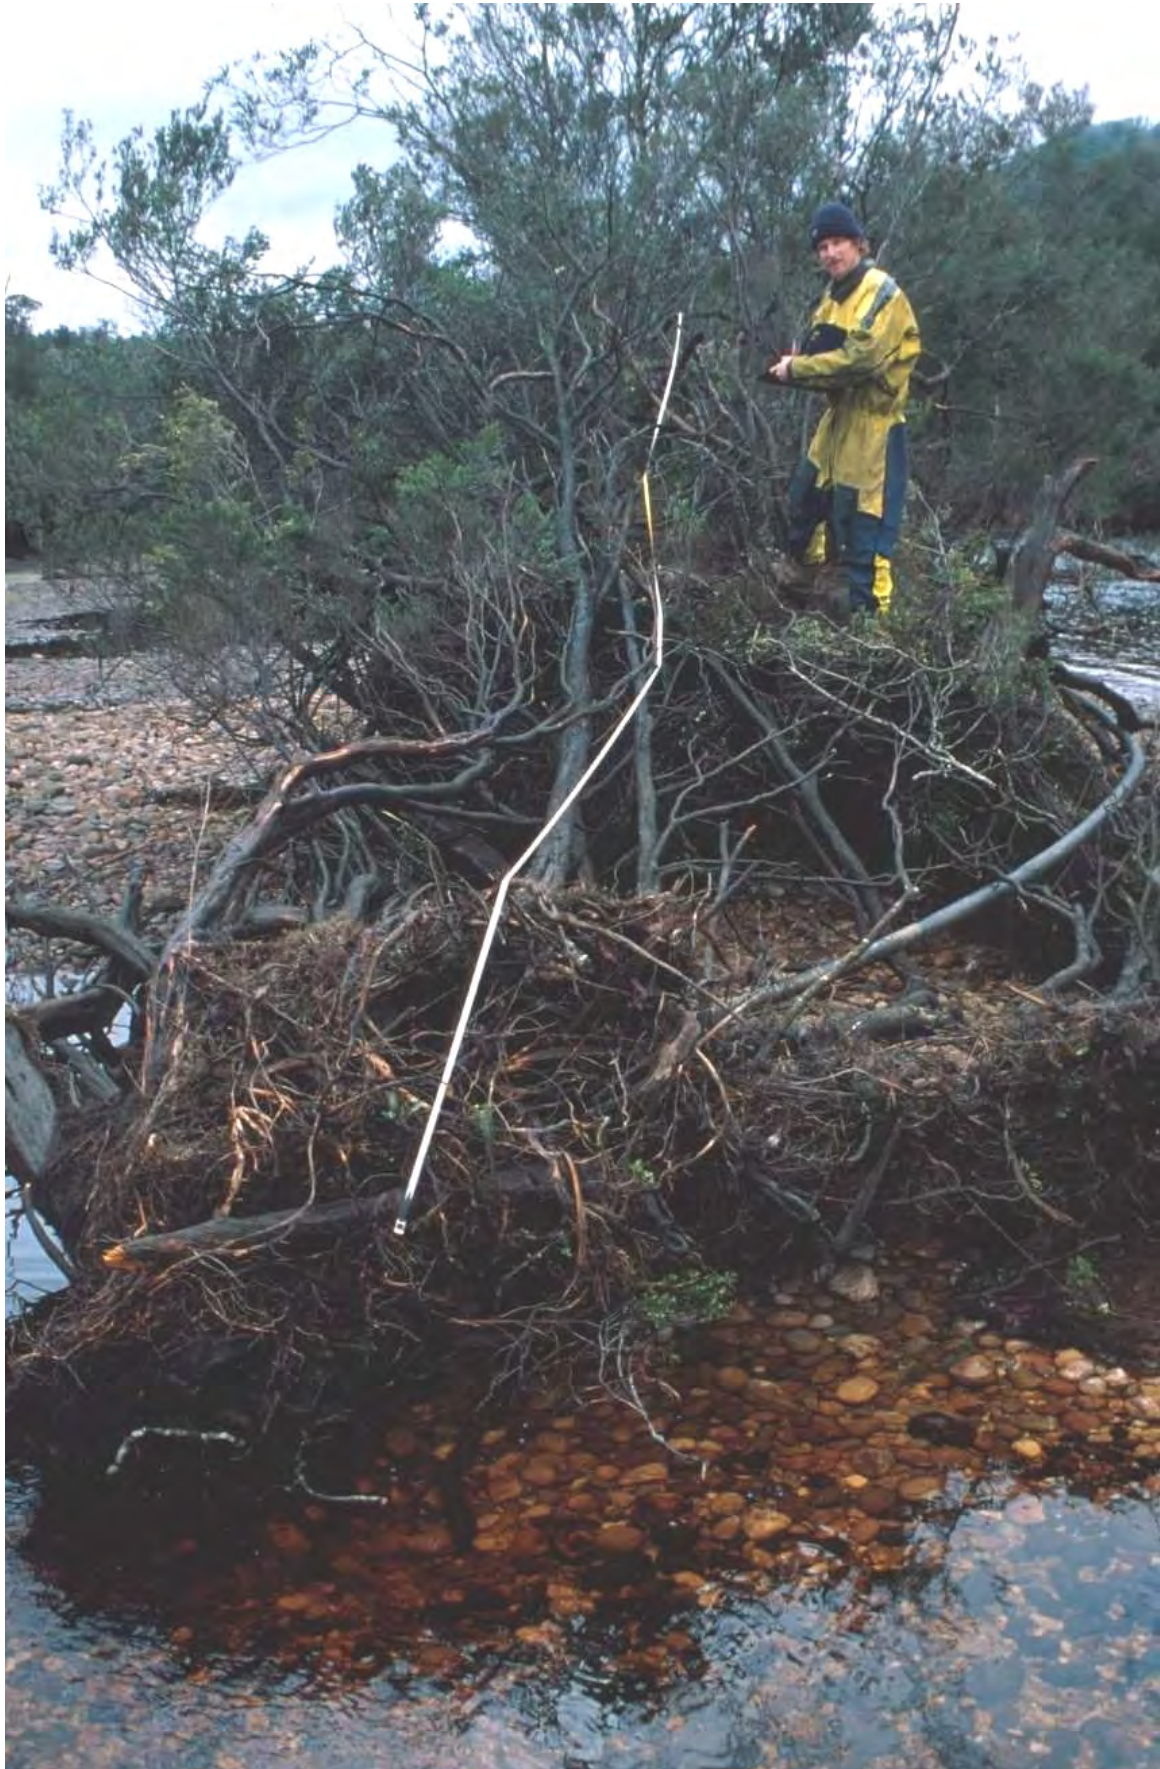
**Plate 28: A linear sand bar deposited behind a bedrock bar just below First Split, at a position in the river where flow is reduced. Sand bars of this sort are completely unvegetated**

Finer sediments (mostly acid-washed white sand) are found deposited in linear bars at positions in the river where flow rates are reduced (e.g. behind the big rock bars just below First Split and just below Kayak Kavern). These large sand bars are completely unvegetated (Plate 28).

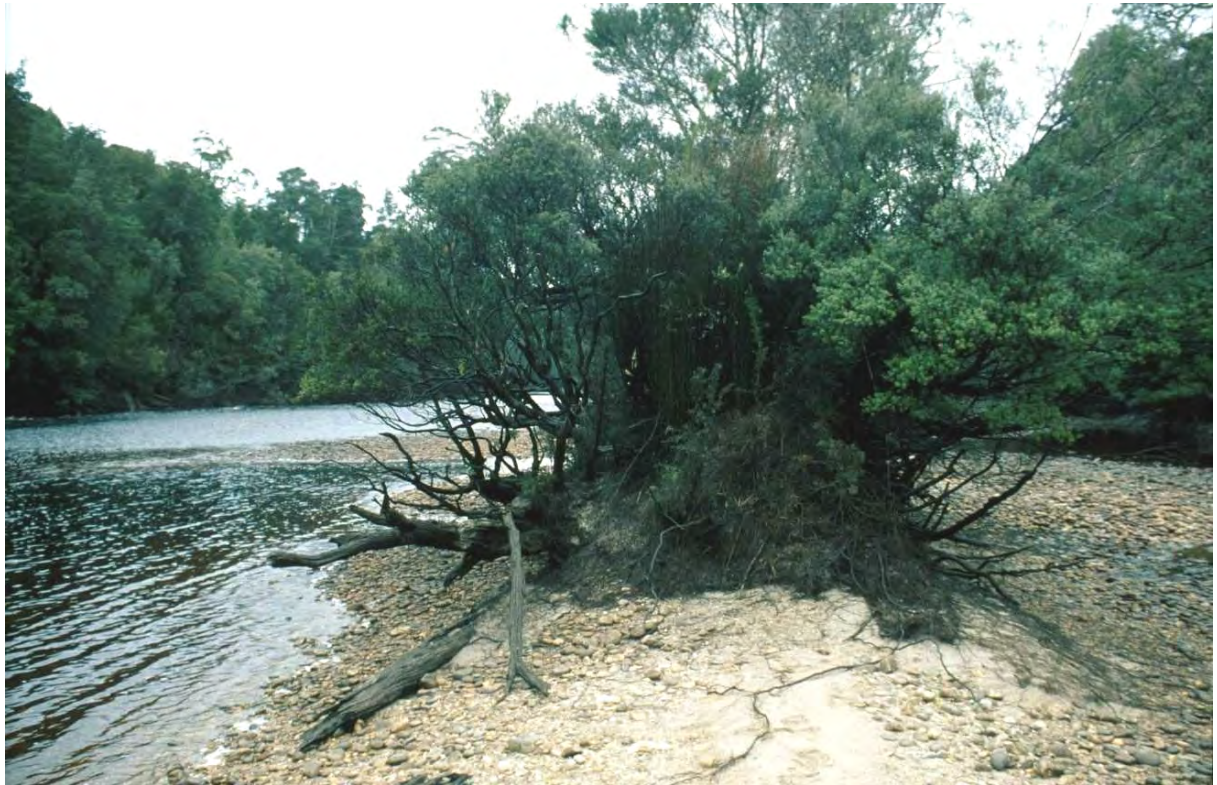
**Plate 29: The eroded and undermined leading edge of an island of vegetation on a cobble bank at Site 71.**

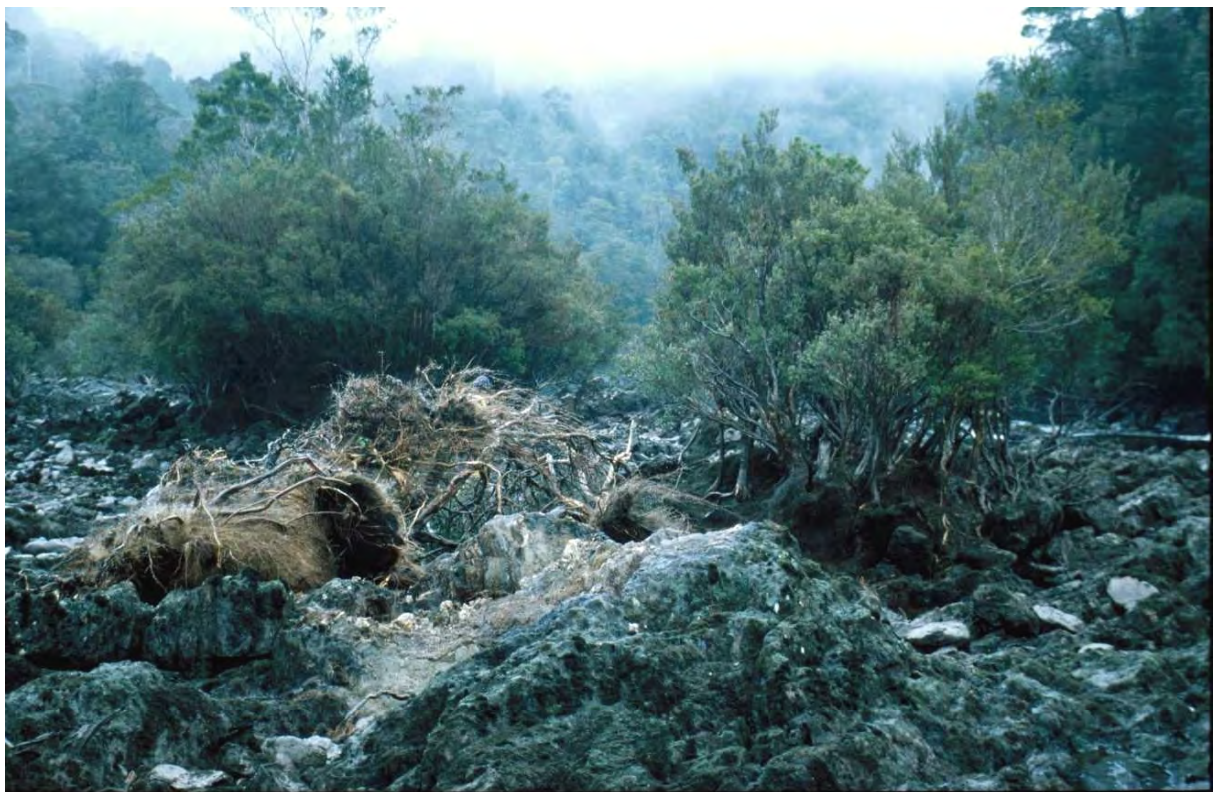
**Plate 30: The eroded and undermined tail end of an island of vegetation on a cobble bank at Site 71**
