Gordon River Monitoring Annual Report 2014–15

September 2015

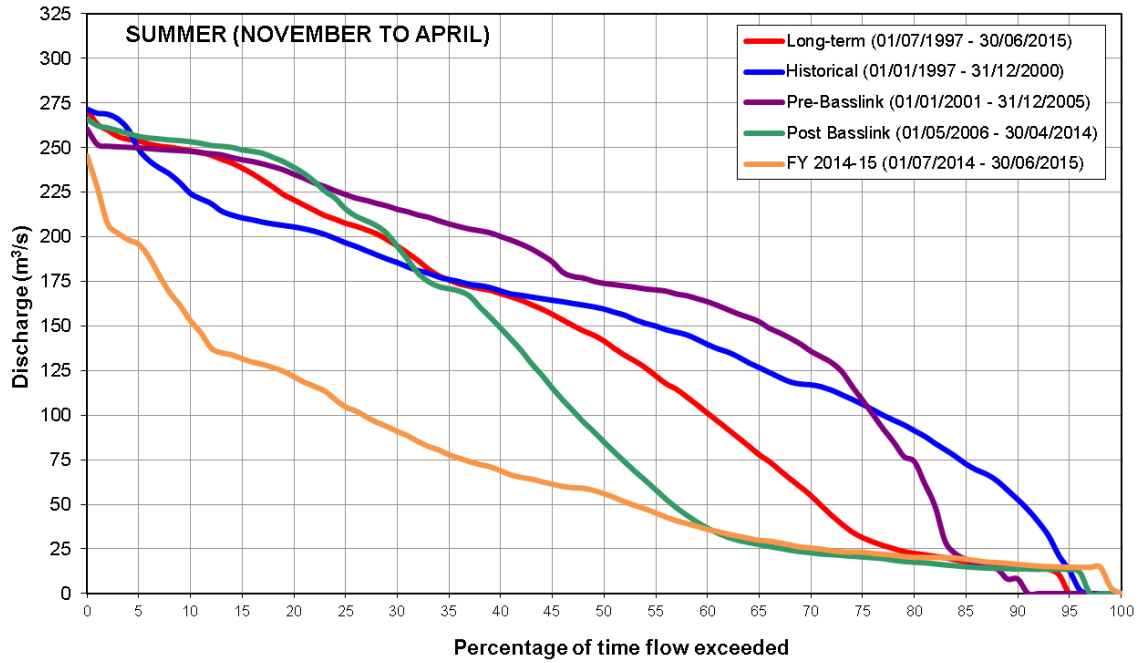
The 2014–15 summer discharge flow duration curve (Figure 2-12) was also a different shape to that of the annual duration curve, and all of the comparative duration curves. The summer of 2014-15 had very few periods of high flow, but a much greater proportion of flows that were found in the middle and lower flow ranges.

Figure 2-12: Duration curves for discharge from the Gordon Power Station using summer data (for the months of November to April inclusive) for selected periods.

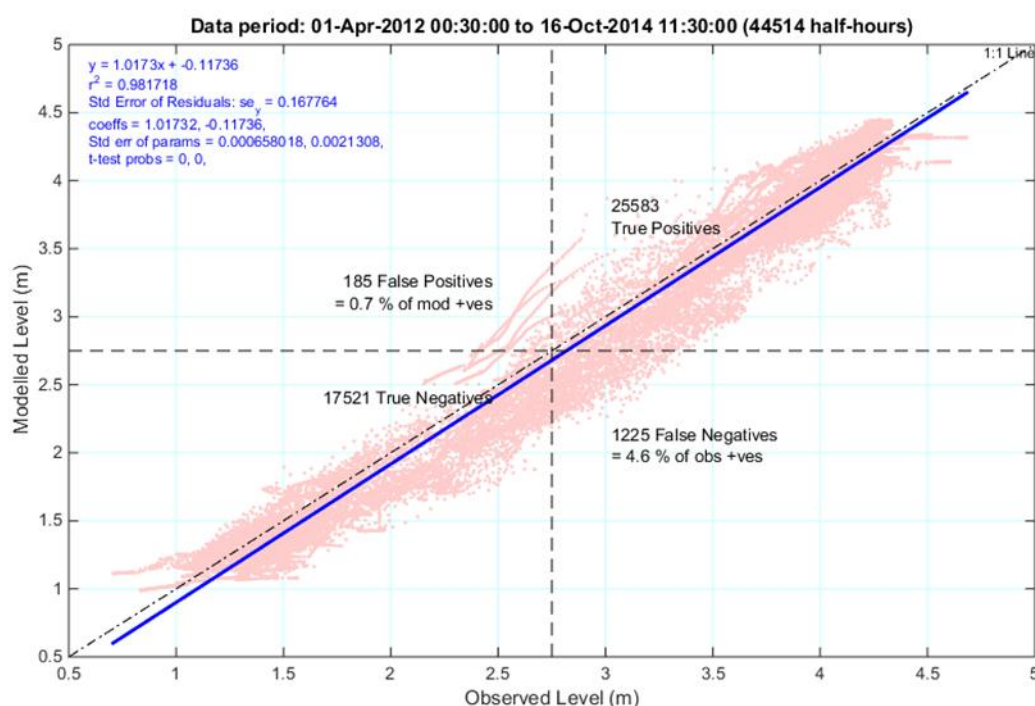
The analysis of 30 minute aggregated data over the complete period for which data was collected (44,514 observations from 1 April 2012 to 16 October 2014) indicated that the modelled data provided 1,225 false negatives (4.6 % of observed positives). This means the actual water level was greater than the trigger level of 2.75 m, while the model indicated that it was less than the trigger level. The ramp-down rule would not have been applied based on these modelled water levels.

This level of false negatives (i.e. 4.6%) has been a feature of the model, which has tended to underestimate the water level in the vicinity of the 2.75 m trigger. Attempts to improve the model in 2013-14, provided little improvement (Hydro Tasmania 2014) in the predictive capacity of the model. Given its limitations, the model has been operating within expectations and will continue to be utilised as a condition for the application of the ramp-down rule.

Figure 2-16: Observed versus modelled water levels for period 1 April 2012 to 16 October 2014 based on 30 minute aggregated data.

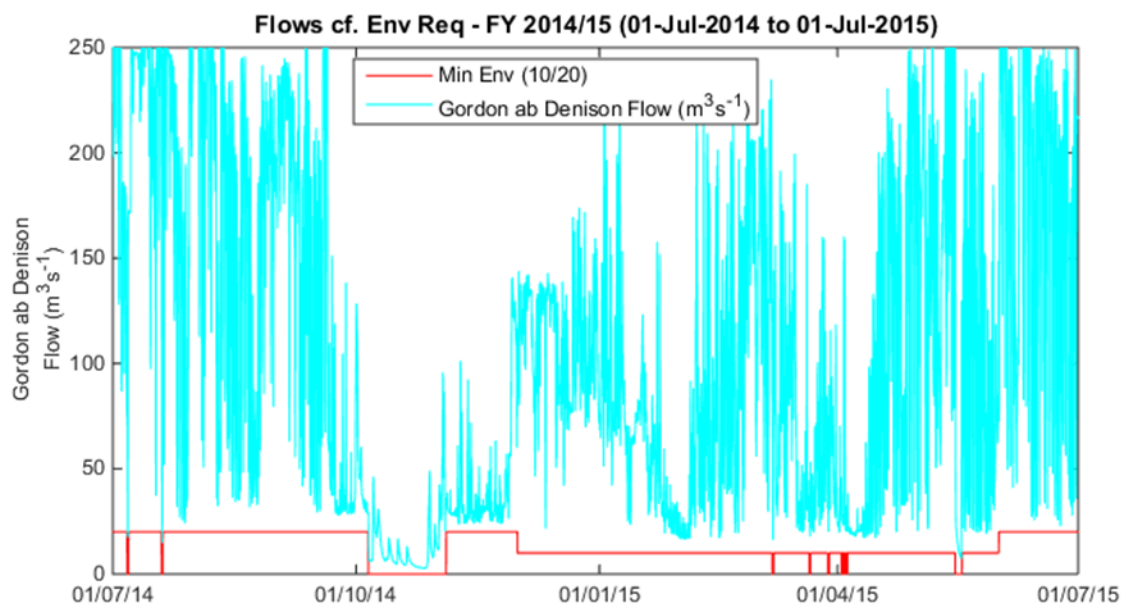
Figure 2-20: Flow recorded (hourly data) at site 65 (Gordon above Denison), from July 2014 to June 2015, and analysis of non-conforming flows.

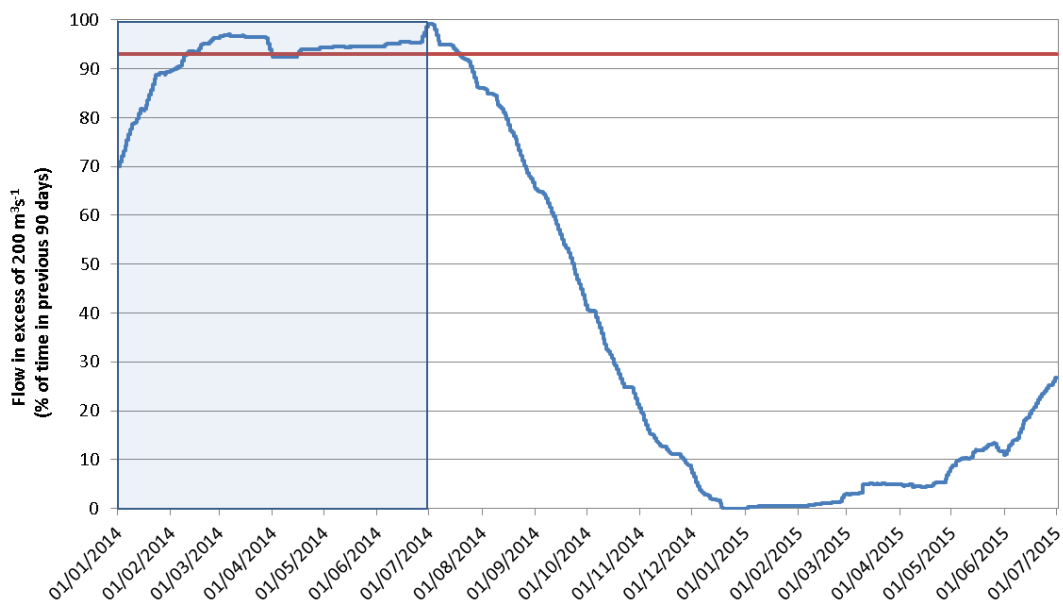
Figure 2-22: Time series of percentage of time in previous 90 days in excess of $200 \text{ m}^3 \text{ s}^{-1}$. Trigger value (93%) marked by red line. Previous reporting period is indicated by blue shading.

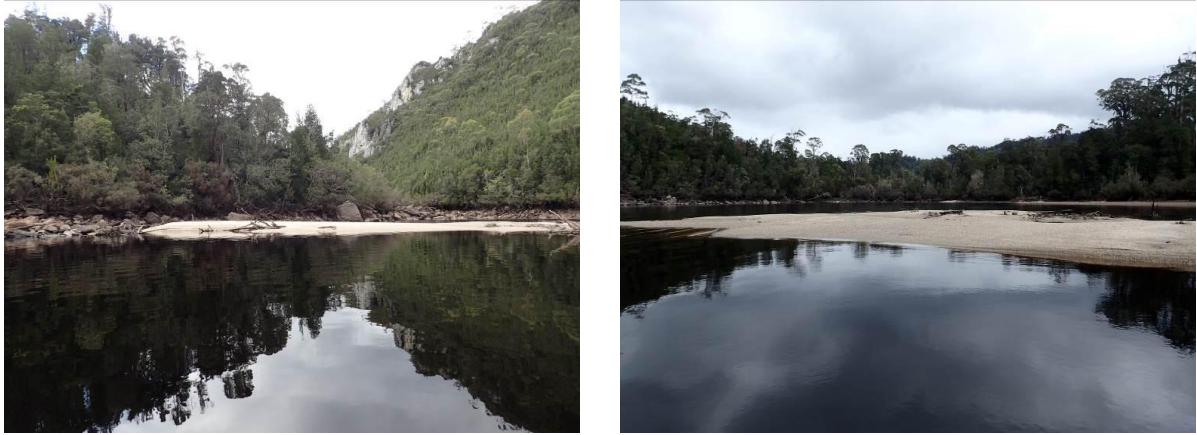
- A new sand bar was observed at the upstream end of zone 2 in the pool downstream of Abel Gorge (Figure 3-8). The bar is in the same location as an 'underwater sand bar' documented in the 1999 aerial photo analysis, but no bar has ever been observed during the Basslink monitoring or Interim monitoring field excursions. The bar was not evident in the 1974 aerial photo analysis of the river. The appearance of the bar is not related to water levels during sampling, as the spring 2014 river levels were not appreciably lower than during other monitoring periods.

Figure 3-8: 'New' sand bar at upstream end of zone 2 with Abel Gorge in the background.

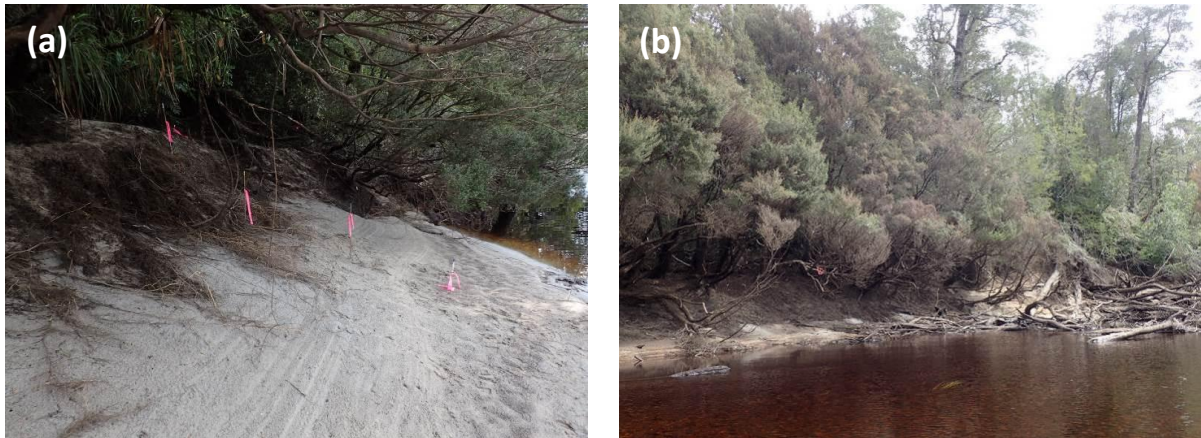
- Scour and seepage features were present on banks, with seepage processes affecting bank toes and scour occurring on the bank faces (Figure 3-10). Seepage features included rilling, tension cracks, small scale sediment flows. Scour eroded root mats and the underlying sand;

Figure 3-10: Scour and seepage features in zone 3. (a) Site 3E - scour on upper bank, seepage on lower bank; (b) site 3H - small sediment flows from under root mat.

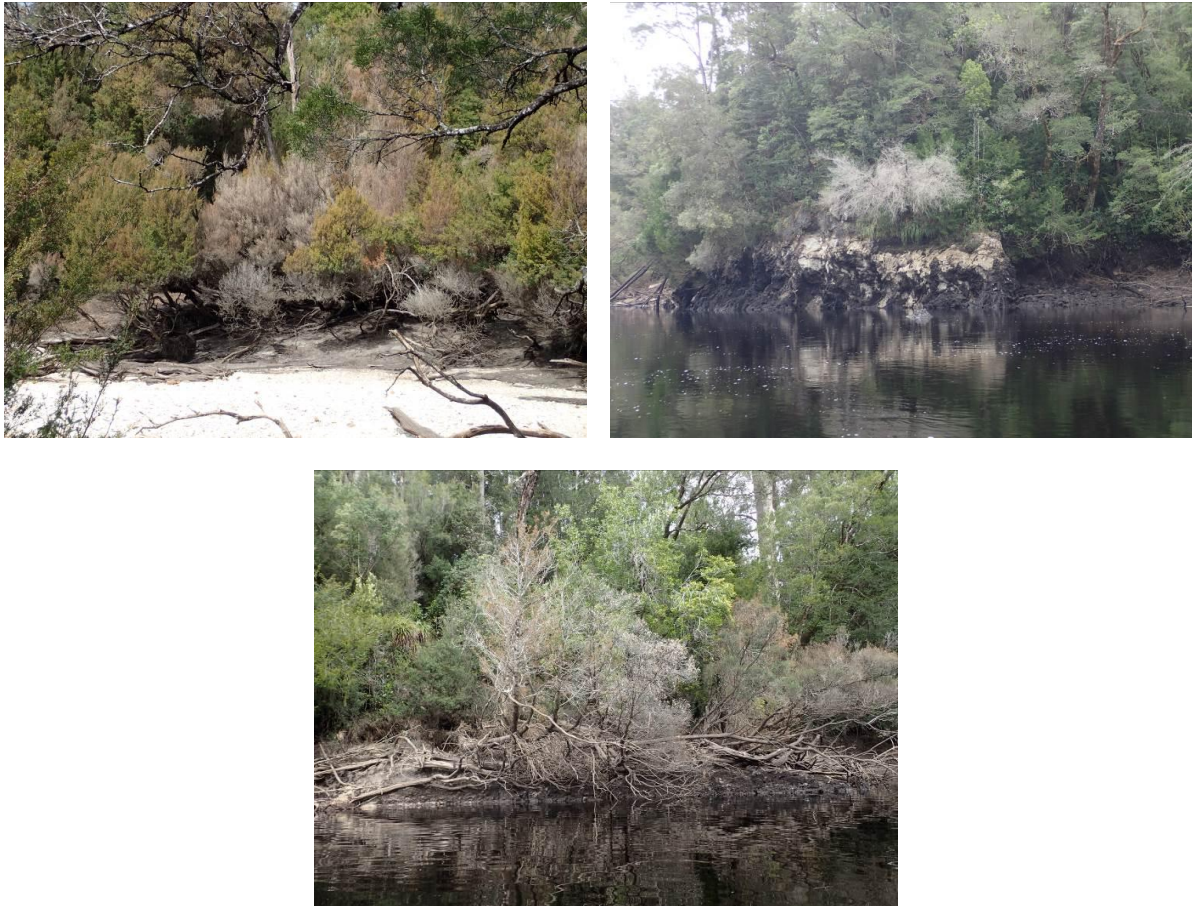
Figure 3-13: Examples of brown or dying vegetation adjacent to the river channel.

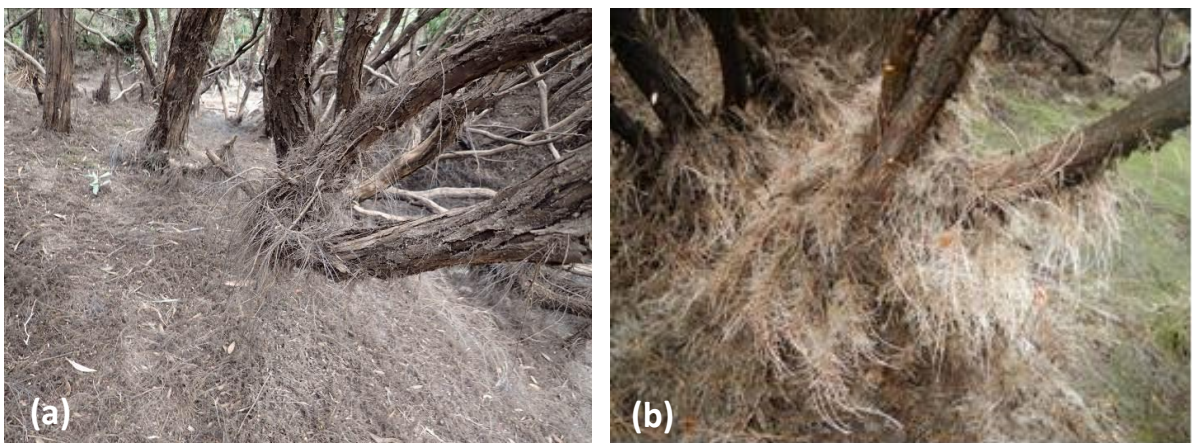
Figure 3-14: Dessicated adventitious roots on tea tree in (a) October 2014 compared to (b) March 2014.

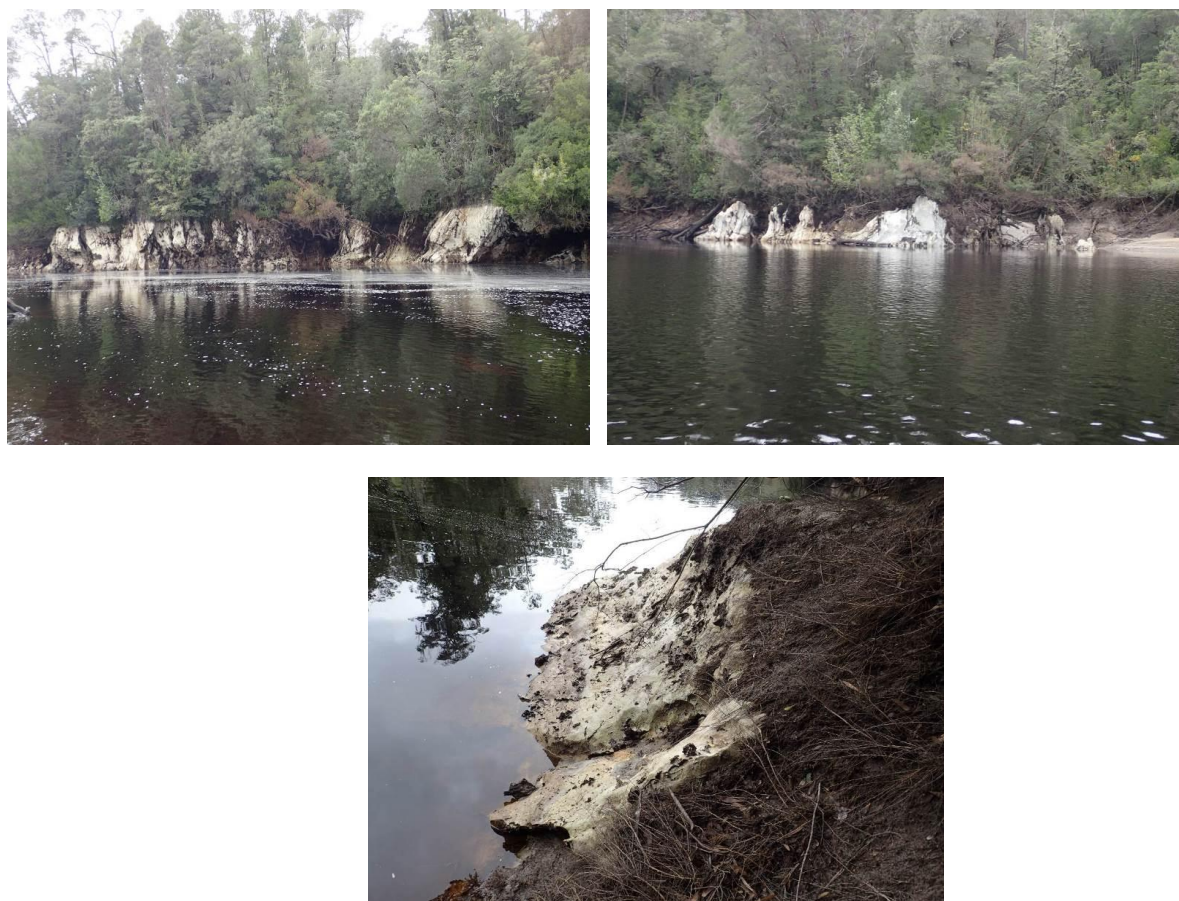
- A field observation, not previously observed in the Gordon River, was the vivid white colour of the dolomite/limestone outcrops in zone 2. These outcrops are generally grey to black in colour, but in October 2014 there were many exposed surfaces which were white, clean and very smooth (Figure 3-15). The removal of the dark

Figure 3-15: The very white surface of dolomite outcrops in zone 2, possibly resulting from abrasion.

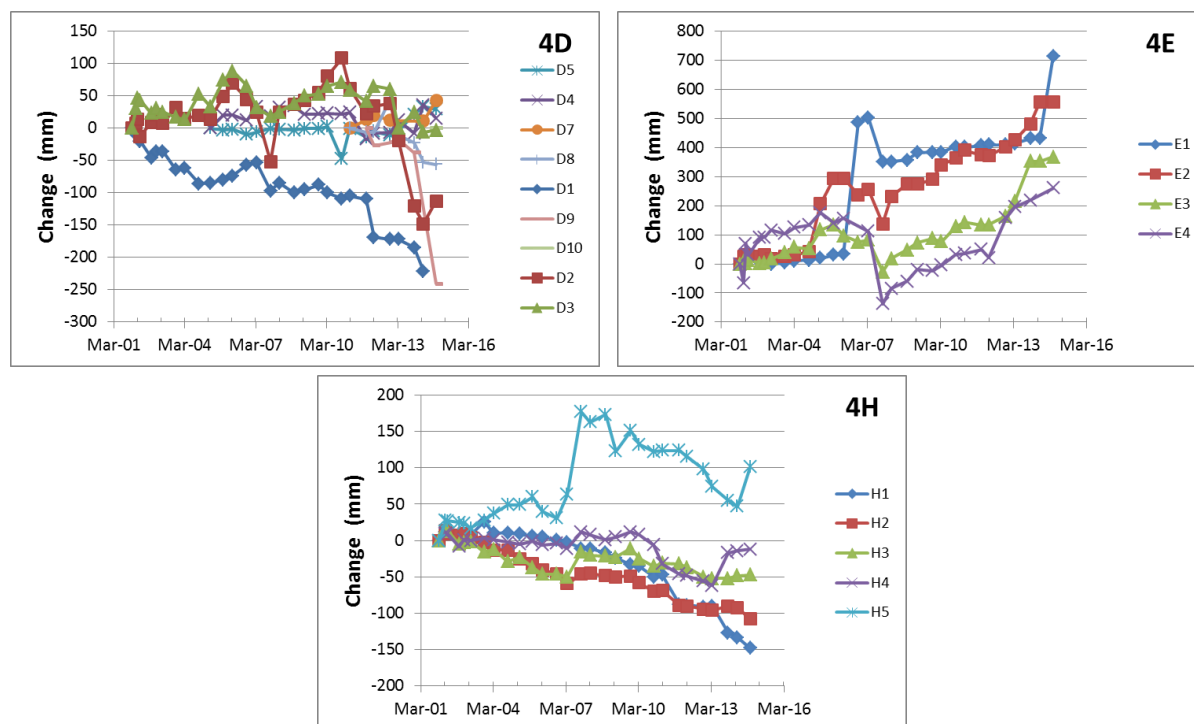
Figure 3-20: Erosion pin results for site 4D, 4E and 4H. Legend shows approximate order of erosion pins from upslope to downslope.
