# Basslink Monitoring Program

## **Gordon River Basslink Monitoring Annual Report**

**2003-04**

September 2004

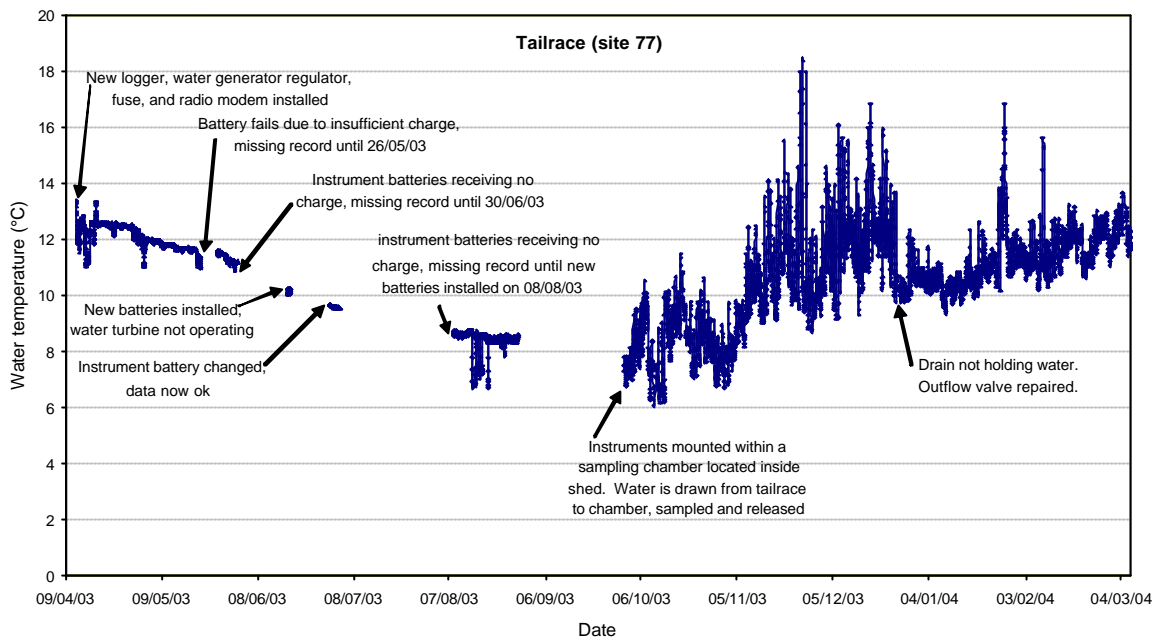
As in previous years, the tailrace dataset suffered from a number of equipment failures during the year. Continuing technical problems have beset this site, associated with the difficulty of powering the probes in their isolated position and with physical damage to the probes caused by the high current velocities in the tailrace. In September 2003 a new arrangement was trialled, which pumped tailrace water up to a monitoring tank in a shed on the top of the bank. This allowed the probes to be powered more reliably while also decreasing the incidence of damage. Data delivery has been much more reliable since this installation took place. Initial problems with the new arrangement meant that some erroneous data were recorded due to premature draining of the sample tank in the shed. Figure 3.4 shows the available record of water temperature at the tailrace site from March 2003 to March 2004.

Apart from the missing data, this figure also indicated some artefacts of the monitoring conditions. Prior to the installation of the remote sampling chamber in September 2003, there was little diurnal variation in the signal as the probes were immersed in the tailrace water. Occasional divergences from this pattern were the result of power station shutdowns which allowed the water temperature at the tailrace to regain ambient levels. Following the installation of the remote sampling chamber there is much more diurnal variation evident. Initially, this variability was the result of an extended power station shutdown which continued until November 25<sup>th</sup>. Around the 7<sup>th</sup> November, the diurnal variability increased again, to reach extraordinary levels late in November. This was the result of the sampling tank draining prematurely, leaving the probes exposed to record the ambient air temperature. This was corrected on 24<sup>th</sup> December and the diurnal variation returned to the more moderate pattern produced by the sampling chamber.

Figure 3.4. Water temperature values in the Gordon River at the power station tailrace.

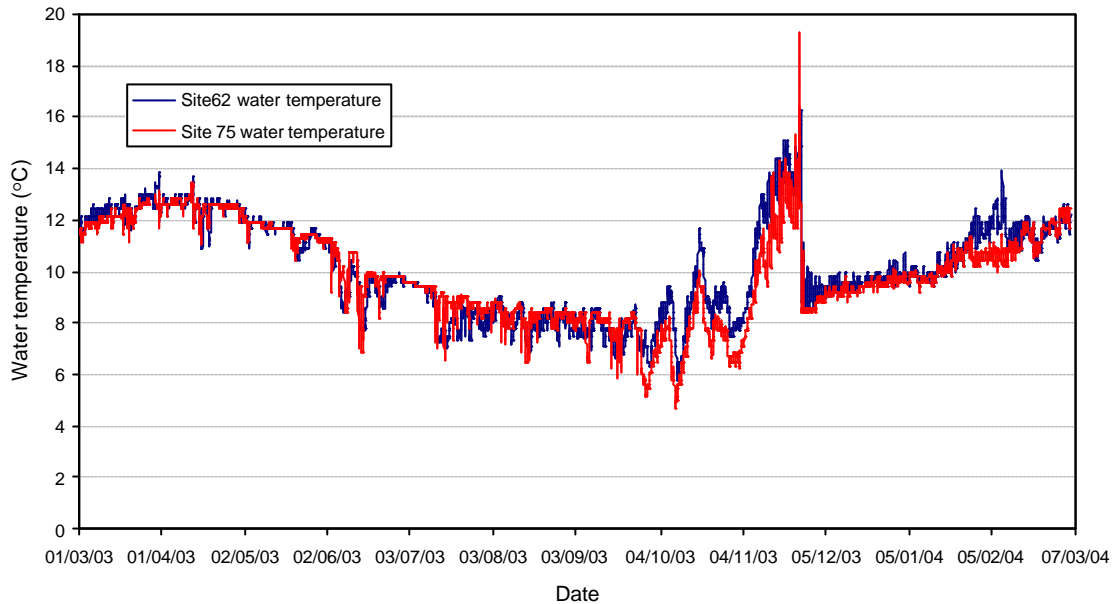
Whilst the tailrace data are telemetered, this is not the case for the other two temperature monitoring sites. The dataloggers at these sites must be downloaded manually. For both sites 75 and 62 the latest available data finish in early March 2004 (corresponding to the last maintenance field trip). This is a consistent time lag each year, rather than missing data. Consequently, the temperature relationships between sites will be discussed in relation to the 12 month period from March 2003-March 2004. While this is outside the usual July-June reporting period, it continues the analysis timeline from the 2002-03 report for these sites. Figure 3.5 shows the water temperature values recorded for sites 75 and 62 for this period.

Figure 3.5. Water temperature data recorded for sites 75 (2 km downstream of the tailrace) and 62 (15 km downstream of the tailrace) over the period from March 2003 to March 2004.

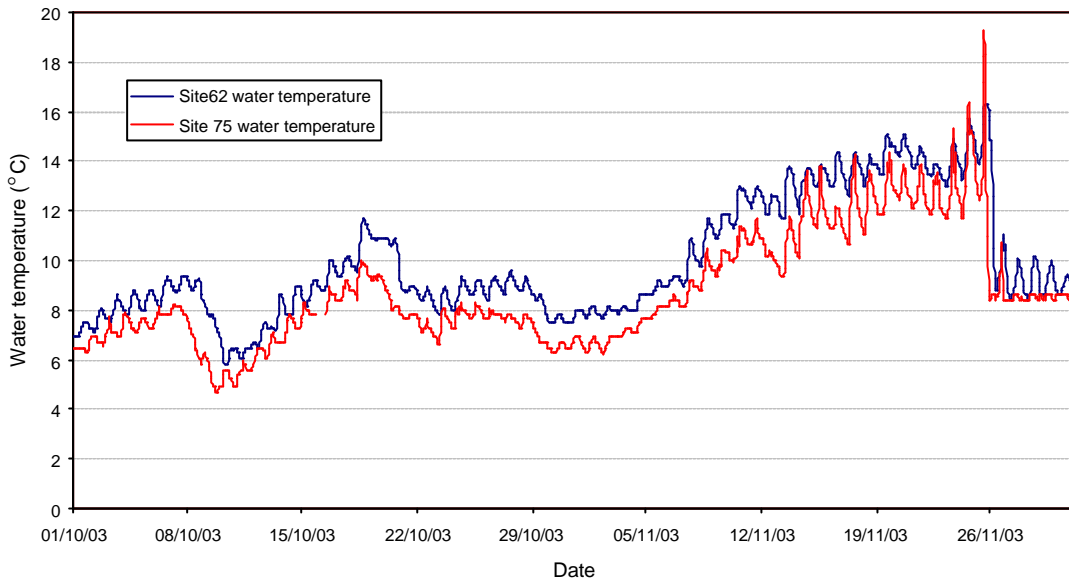
Figure 3.6. Water temperatures recorded at sites 75 and 62 over the period of October and November 2003, during an extended power station shutdown. The shutdown ended on November 25<sup>th</sup>.

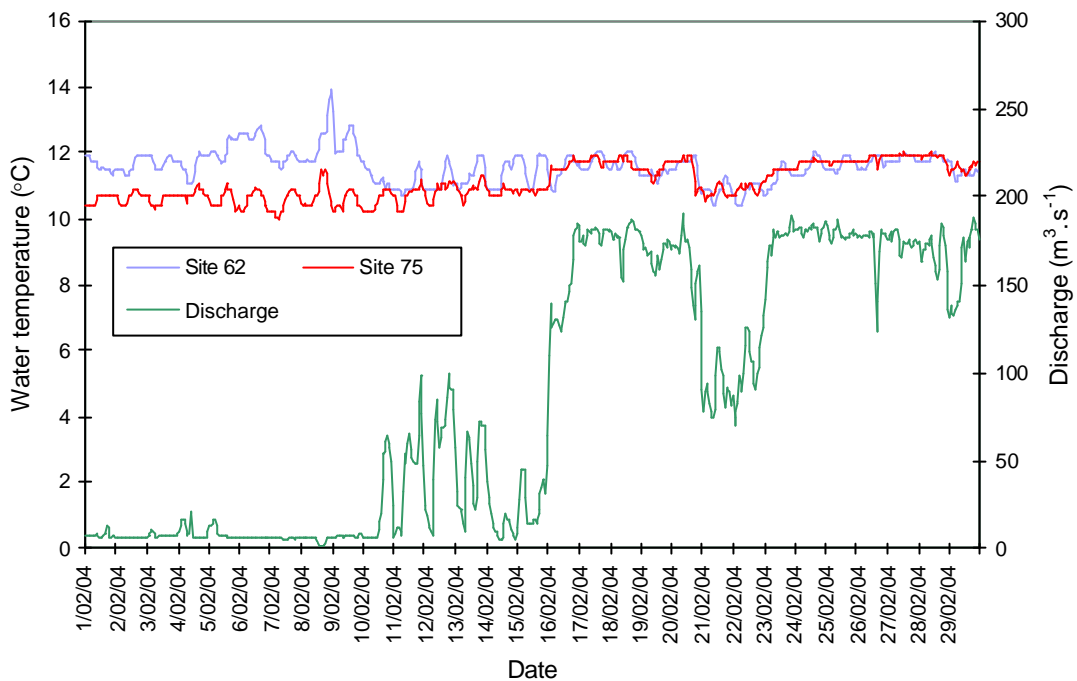
Figure 3.8. Water temperatures at sites 75 (2 km downstream of the tailrace) and 62 (15 km downstream) and corresponding power station discharge for February 2004.

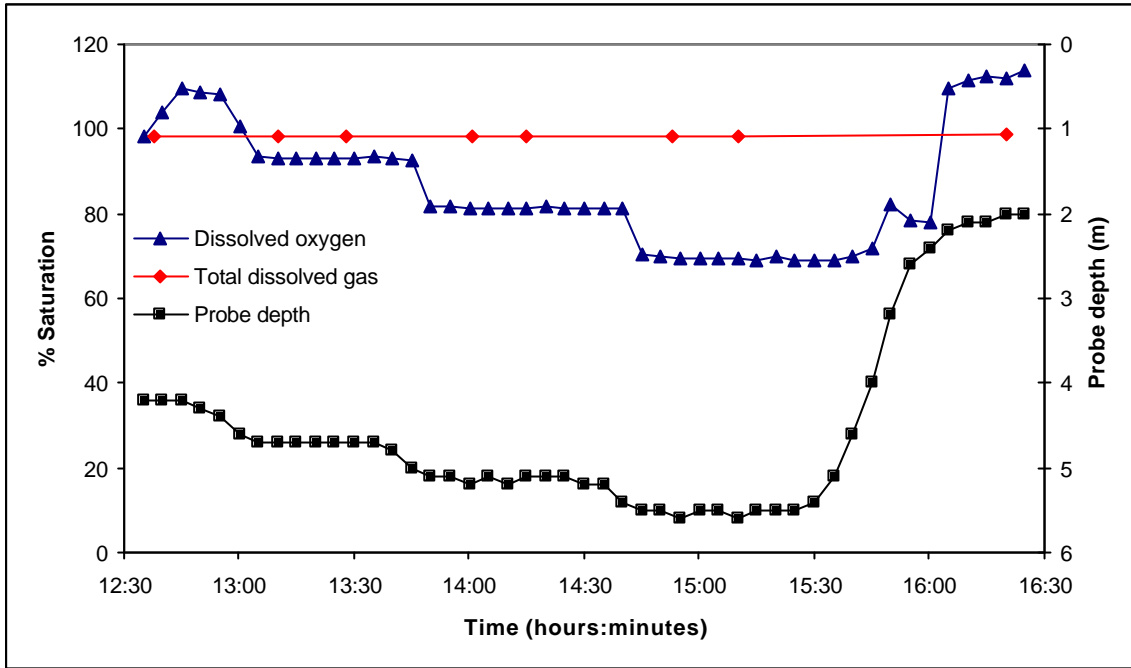
Figure 3.10. Dissolved oxygen, total dissolved gas saturation and tailrace probe depth during the tailrace trial. DO and TDG levels are shown as percent saturation.

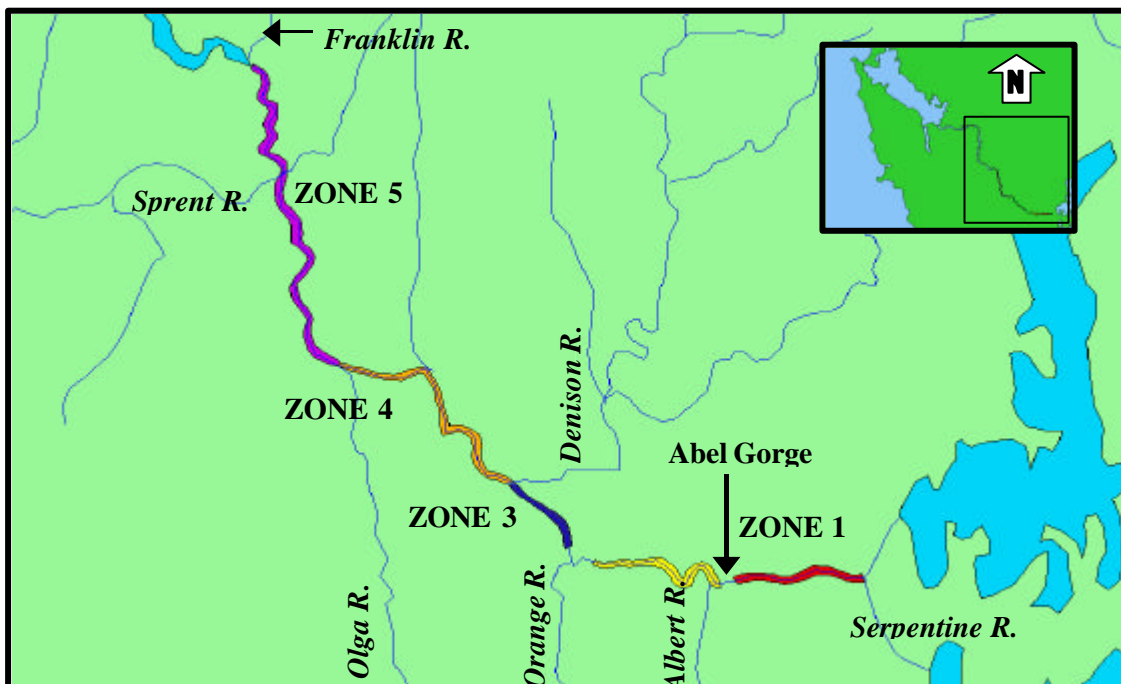
Figure 4.1. Geomorphology monitoring zones in the Gordon River.

Geomorphology monitoring included measuring 200 erosion pins and 25 scour chains located at 48 sites in the Gordon River on a 6-monthly basis, and photo monitoring of an additional 54 sites on an annual basis in March each year. Site locations and site descriptions are listed in the Gordon River Basslink Monitoring Annual Report 2002-03. The Gordon River was divided into five zones, as shown in Figure 4.1, and the sites were numbered according to their position in each zone.

This report provides results of the November 2003 and April 2004 sampling trips and provides general conclusions of baseline data obtained from April 2002 to April 2004. The locations of the riparian vegetation monitoring sites are shown in Figure 6.1. The Gordon River sites are numbered with reference to the fluvial geomorphology zone system (see Figure 4.1). There are no riparian vegetation monitoring sites in zone 1.

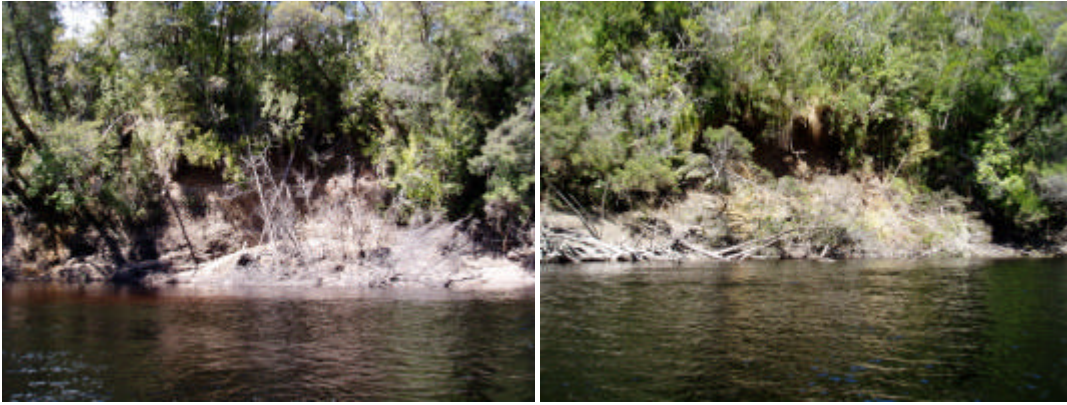
Photo 4.1 Two new bank failures observed in October 2003 in zone 2.

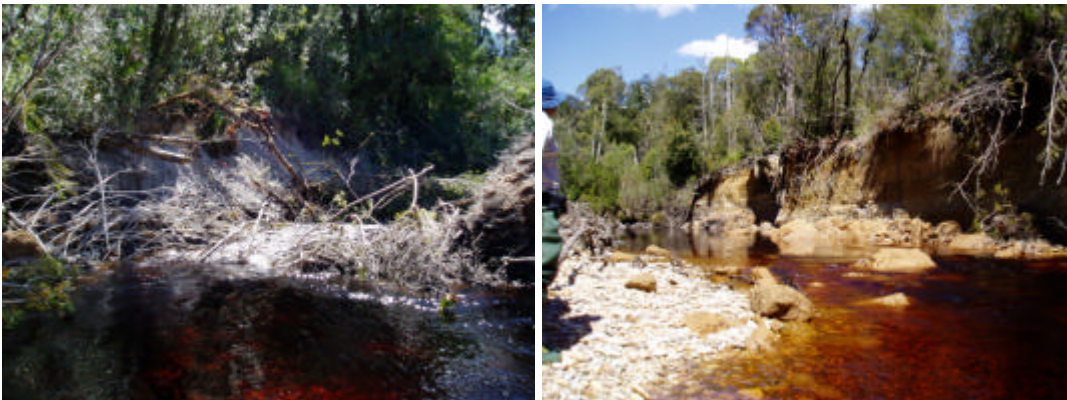
Photo 4.2. New slip in the lower Albert River, observed in October 2003: (left) Left bank, and (right) lower Albert River looking upstream. Large sediment blocks have been transported by flow.

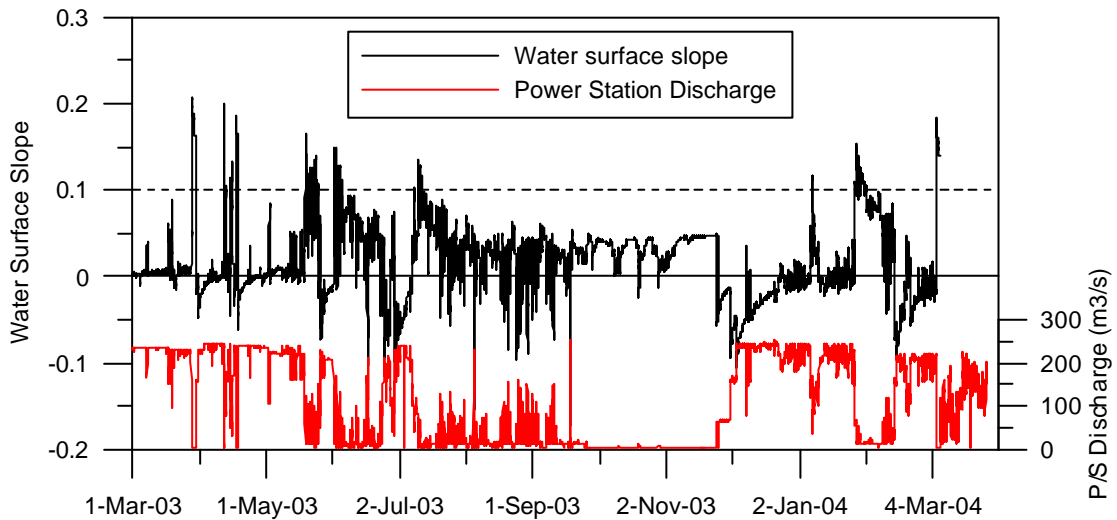
Figure 4.7. In-bank water surface slopes as determined by the difference in water level between Probe 3 and Probe 1, and power station discharge. A positive slope indicates the in-bank water surface is sloping towards the river. Slopes in excess of 0.1 are considered to pose a high risk of seepage erosion

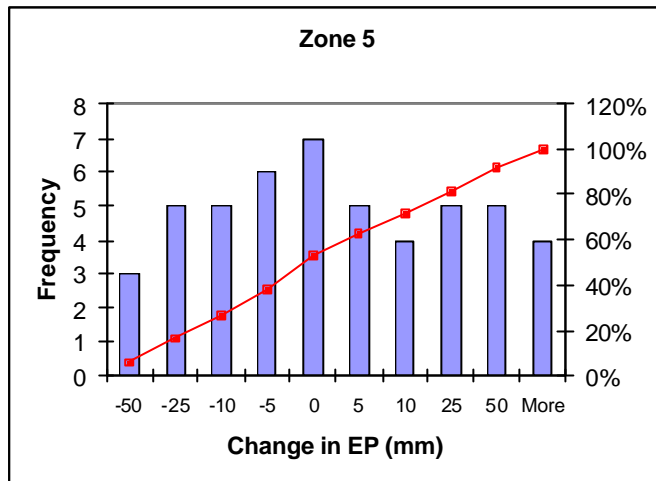
Figure 4.21. Changes in erosion pins between October 2003 and March 2004. Negative values indicate deposition, positive values indicate erosion.
