Basslink Monitoring Program

Gordon River Basslink Monitoring Annual Report

2010–11

Volume II: The Appendices

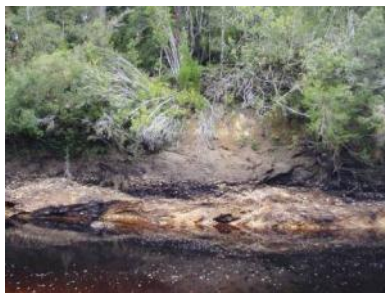
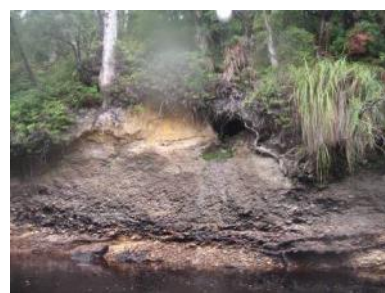
Photo A4-19 Zone 1, site 4 – 1 March 2008 (left), 21 March 2009 (right – wrong site, slightly upstream)

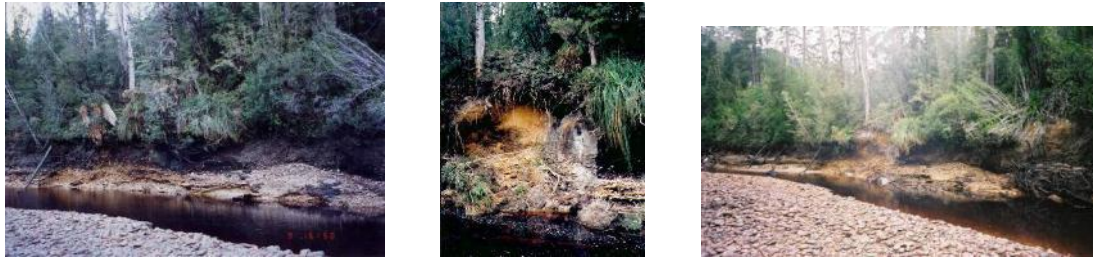
Photo A4-21 Zone 1, site 4b – 9 March 2002 (left), October 2002 (middle). Note vegetation at base which is absent on 29 March 2003 (right)

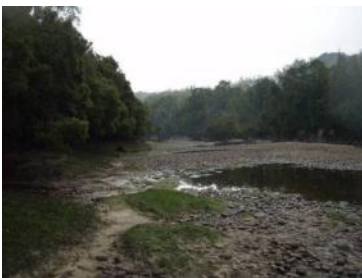
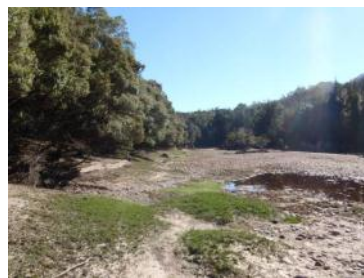
Photo A4-39 Zone 2, site 1b – 21 March 2009 (left), 13 March 2010 (right)

Photo not taken 1 March 2008 (field error) – no changes noted in field notes.

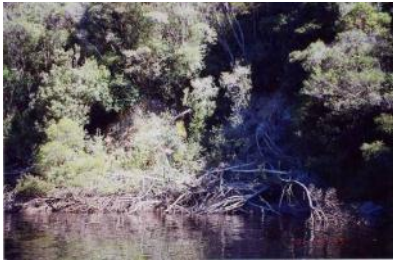
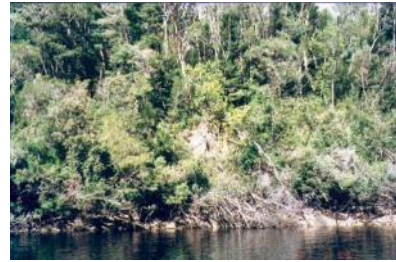
Photo A4-248 Zone 5, site 14 – 10 March 2002 (left), and March 2003 (right)

Not taken in March 2004 – missed it and went down rapids (too late to return). Same thing happened in April 2005 – very tricky site.

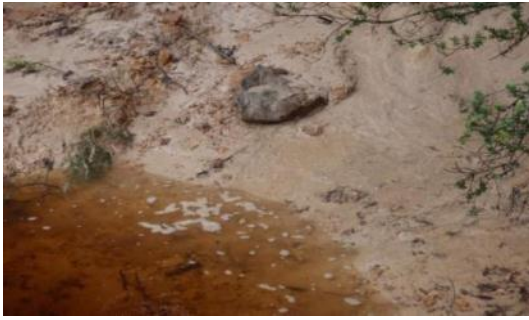
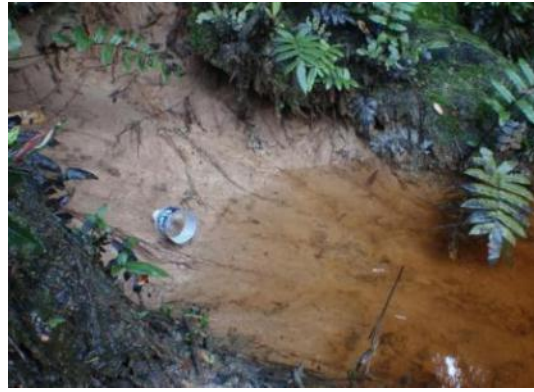
The second stage of drawdown occurred when the river level fell to near or just below the ground water level in the bank. During this period, water began to drain from the bank, and contained low concentrations of sediment, except for the two high-saturation trials, when small scale seepage was observed during this stage (Photo A5-4).

Photo A5-4 Initial, diffuse draining of bank during drawdowns and ramp-downs

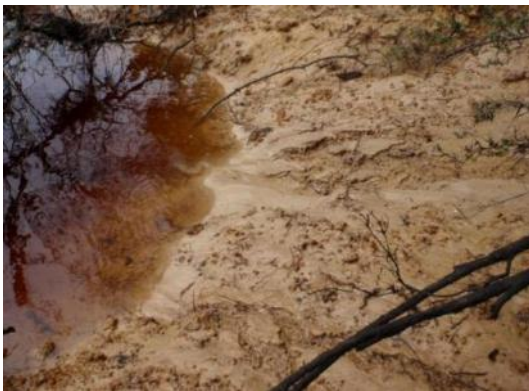
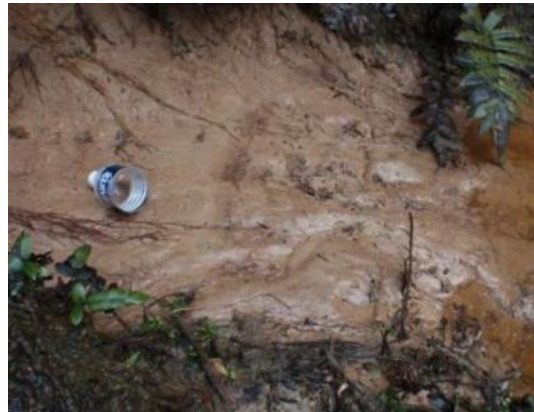
Photo A5-5 Rilling of bank toes during drawdowns

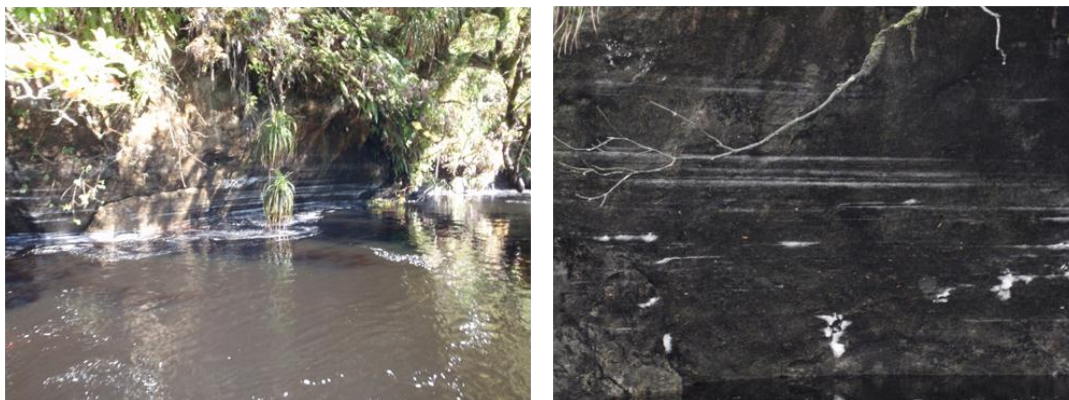
Photo A5-7 Foam lines on bedrock bank during $45 \text{ m}^3 \text{ s}^{-1}$ per hour ramp (left) and during high-saturation, non-ramped drawdown (right)

- during both ramp-downs, there was extensive draining of water through the degraded root mat, leading to water dripping off the vegetation and the root mat;
