Gordon River Monitoring Annual Report 2012–13

Basslink Interim Monitoring Program

Date 30 September 2013

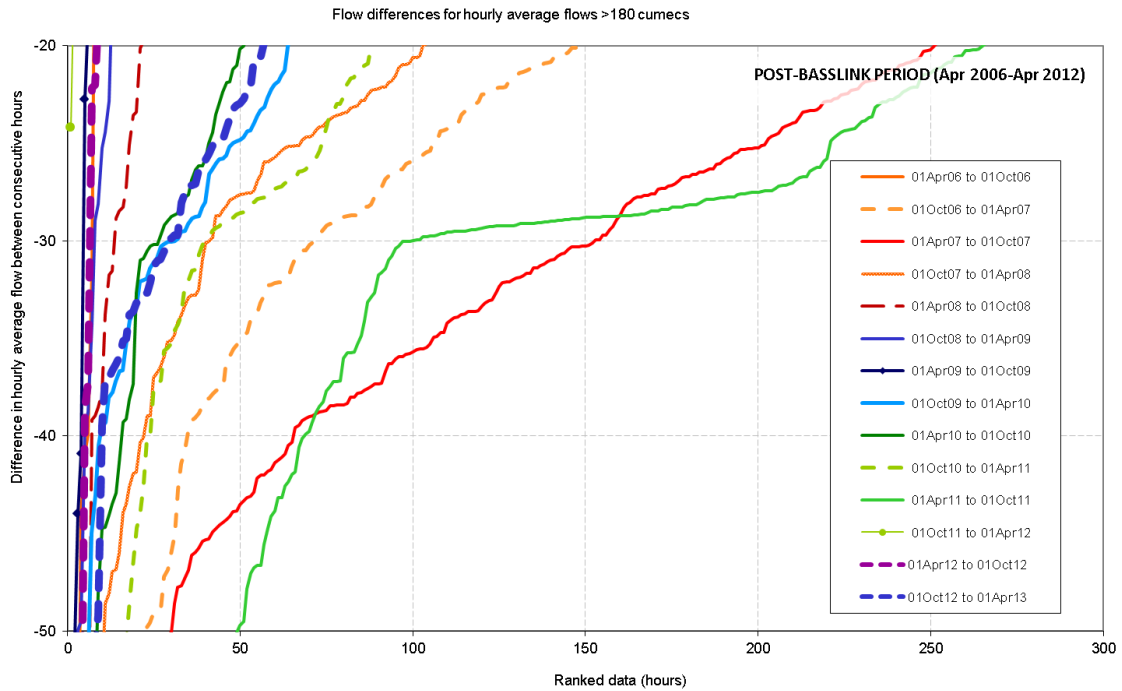
Figure 2-14: Flow change frequency plot showing the ranked rate of flow reductions data for six month periods occurring while power station discharge was greater than $180 \text{ m}^3 \text{ s}^{-1}$ for 2006–13.

Bank saturation conditions during 2013 were high, leading to the requirement to implement the ramp-down rule. The influence of the revised ramp-down rule was evident in the fewer number of rapid reductions in flow compared to similar periods of power station operation in April to October 2007 when banks also were saturated (Figure 2-13). Decreases in flow under saturated conditions in April to October 2007 were often substantially greater than $30 \text{ m}^3 \text{ s}^{-1}$ per hour, as the previous ramp-down rule allowed for uncontrolled ramping if flows remained $>150 \text{ m}^3 \text{ s}^{-1}$, regardless of the saturation conditions of the bank.

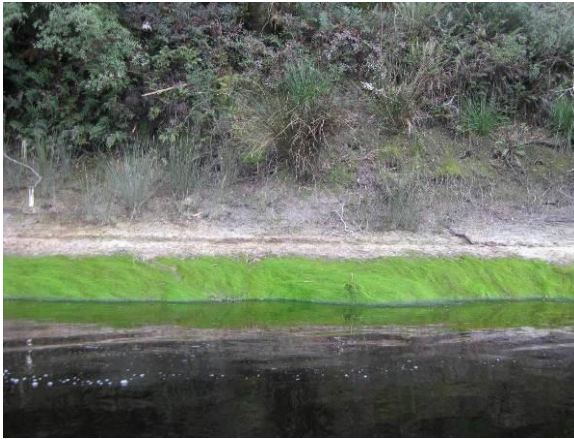
Figure 3-15: Algae on bank toe in erosion pin site 2C (zone 2), with increased vegetation upslope.

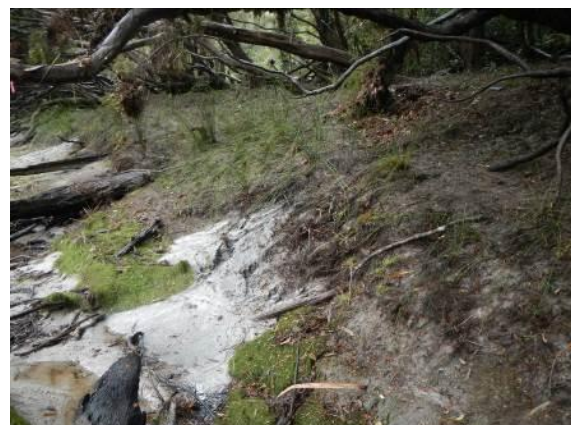
Figure 3-24: Seepage deposits derived from the transport of sand from beneath the degraded tea tree root-mat.

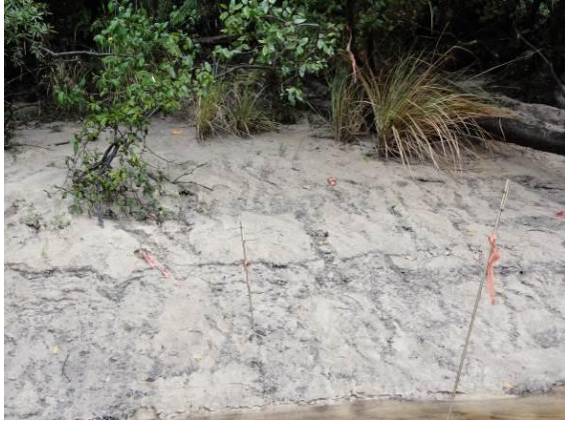
Figure 3-25: Rilling of bank toe at erosion pin site 4A.

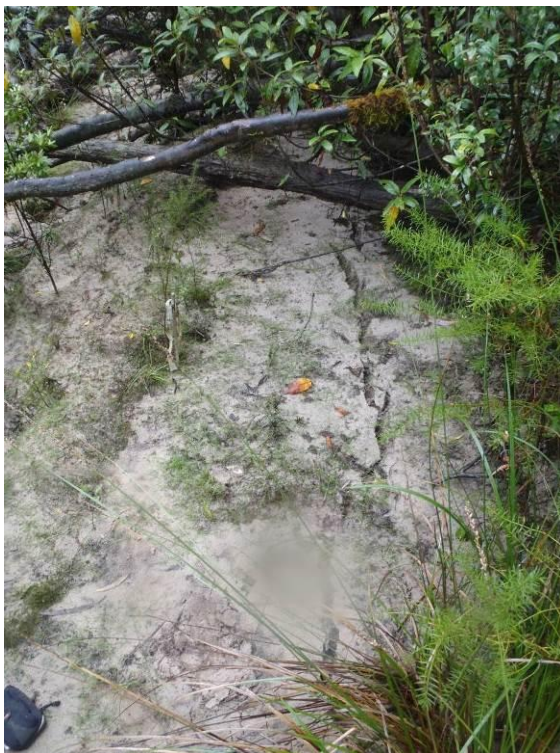
Figure 3-27: Tension cracks in bank at erosion pin site 5A.

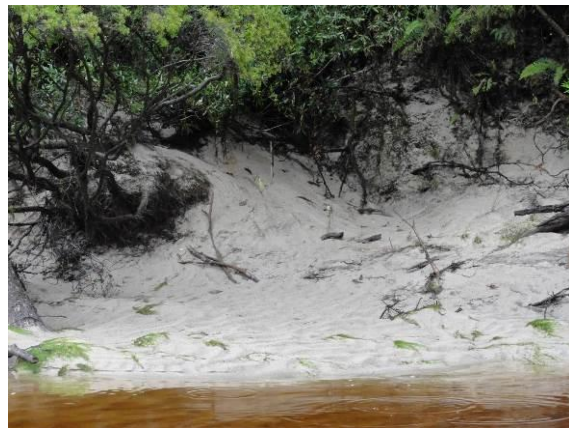
Figure 3-28: Fluvial sand deposition at erosion pin site 3Ea.
