Gordon River Monitoring Annual Report 2013–14

Basslink Interim Monitoring Program

30 September 2014

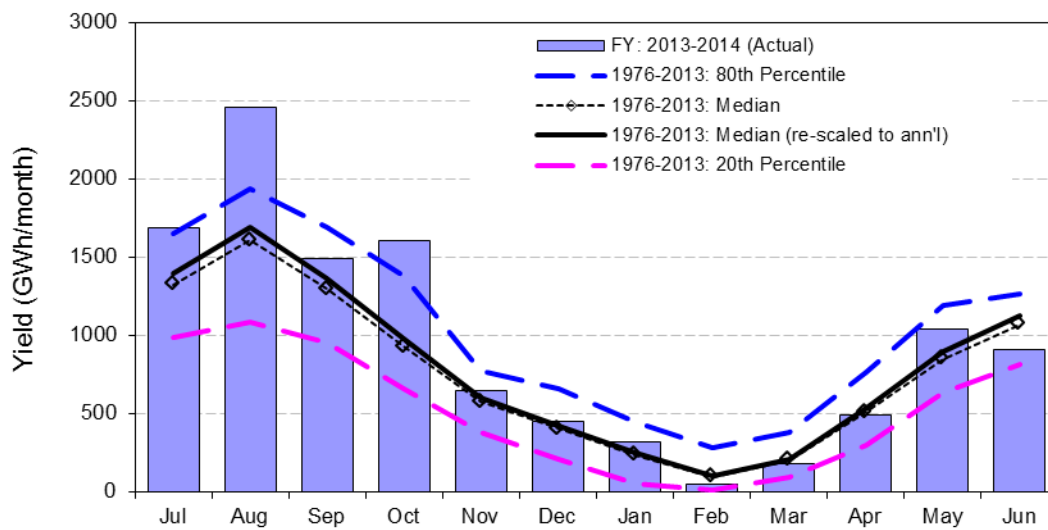
Figure 2-6 shows the total system yield during 2013–14 compared with the long-term (1976–2013) median, 20th and 80th percentile inflows. The most pronounced above average inflows were observed in July, August and October 2013, while only two months (February and June 2014) had below median yields.

Figure 2-6: Monthly total system yield for 2013–14 compared to the long-term median, 20th and 80th percentiles for 1976–2013.

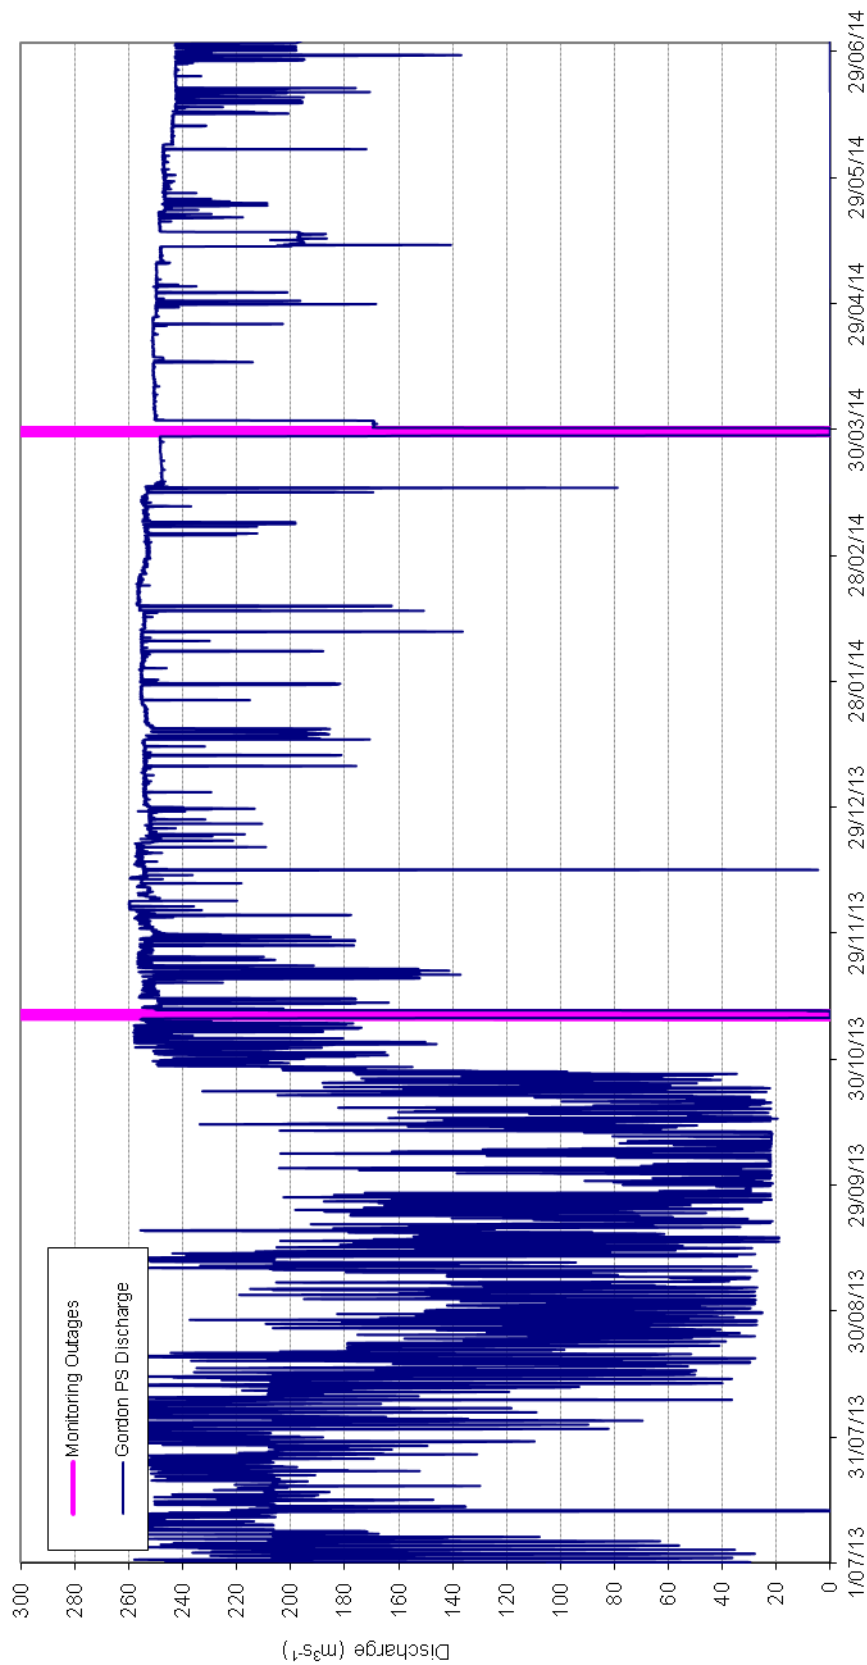
Figure 2-8: Gordon Power Station discharge (hourly data) from July 2013 to June 2014. Pink vertical lines indicate monitoring events.

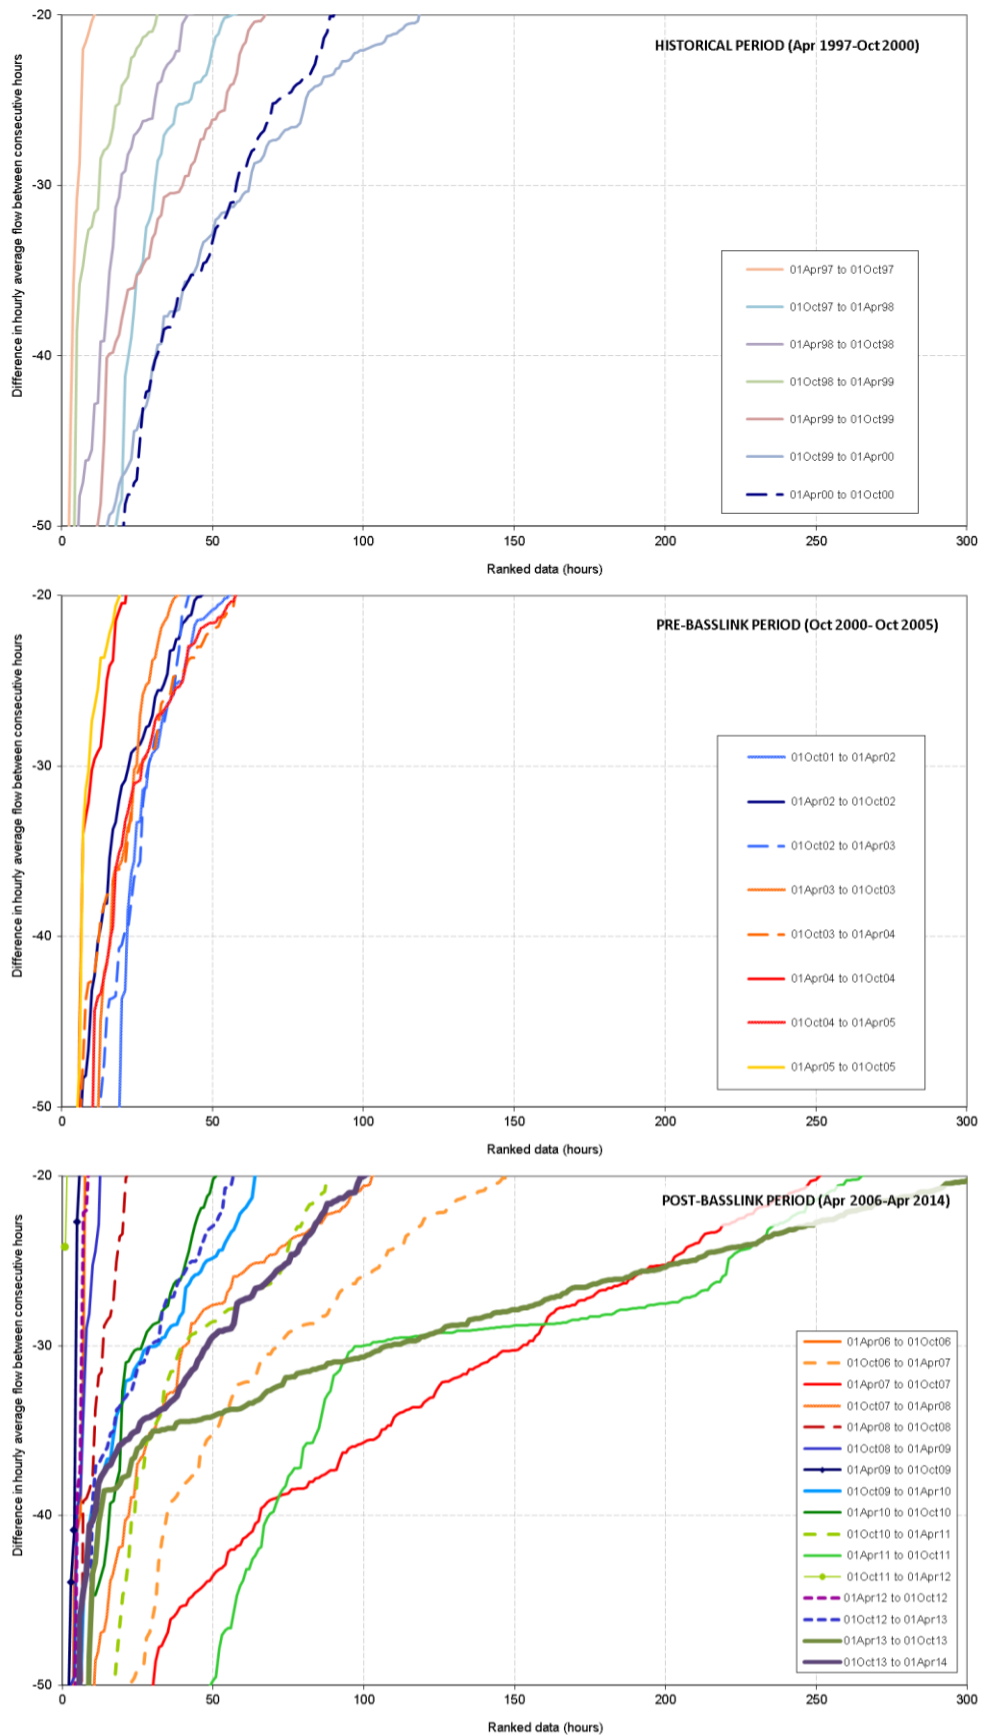
Figure 2-14: Flow change frequency for six month periods of ranked flow rate reductions while power station discharge was more than $180 \text{ m}^3 \text{ s}^{-1}$.for historical, pre-Basslink and post-Basslink periods.

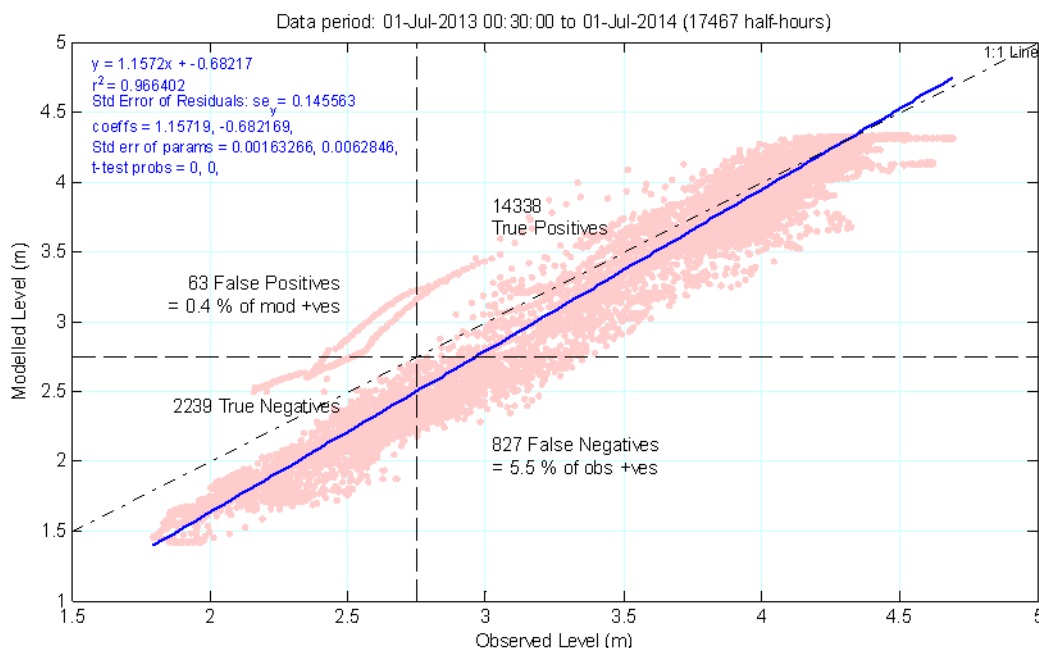
The bank saturation model provides estimates of the water level in the river banks to determine when the trigger level of 2.75 m was exceeded (Figure 2-19). The analysis of 30 minute aggregated data indicated that over the audit period (1 July 2013 to 30 June 2014) the modelled data provided 827 false negatives (5.4% of observed positives) where water levels were greater than the trigger level of 2.75 m, while the model indicated that they were less than this level. There were only 63 false positives (0.4% of compared values) for the audit period, however these are of little concern.

The recalculation of co-efficients (a_i) provided only minor improvement in the number of false negatives calculated for 2013-14, from 5.4 % to 5.2 % of observed positive values. Given this improvement is very small and the operation during 2013-14 was unusual, the regression coefficients in the current model will be maintained.

Figure 2-19: Observed versus modelled water levels for period 1 July 2013 to 30 June 2014 based on 30 minute aggregated data.

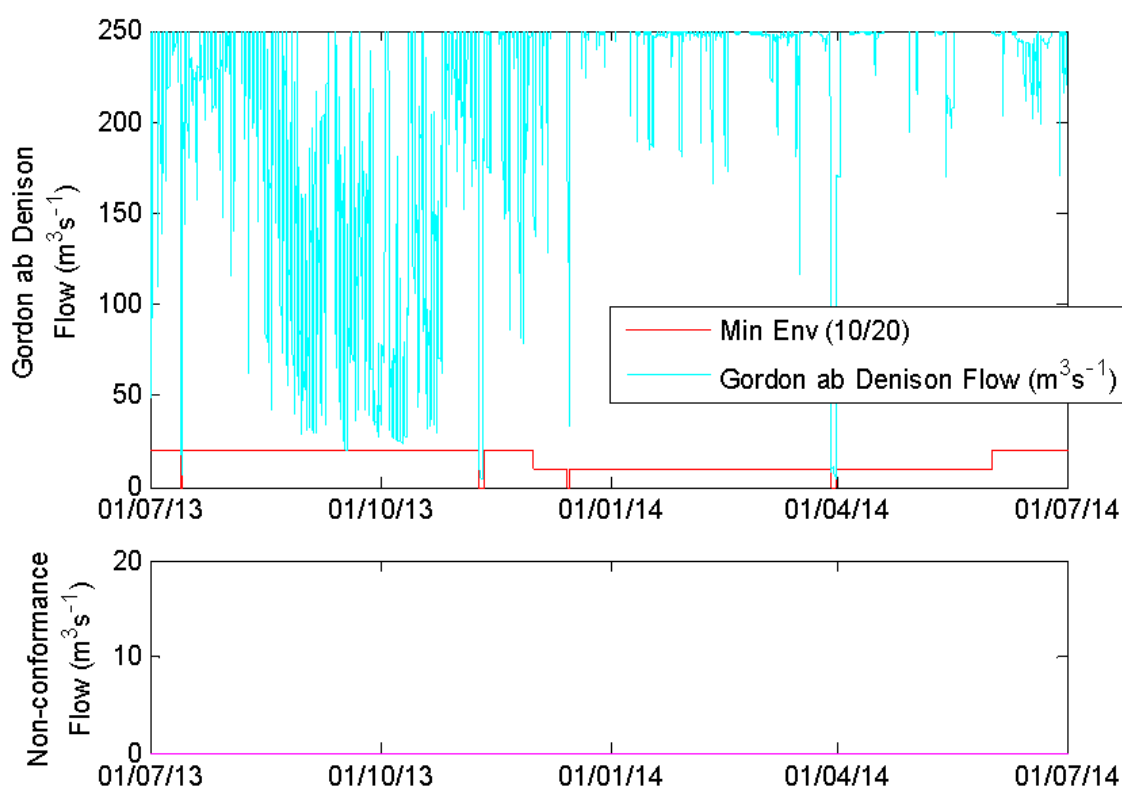
Figure 2-23: Flow recorded (hourly data) at site 65 (Gordon above Denison), from July 2013 to June 2014, and analysis of non-conforming flows.

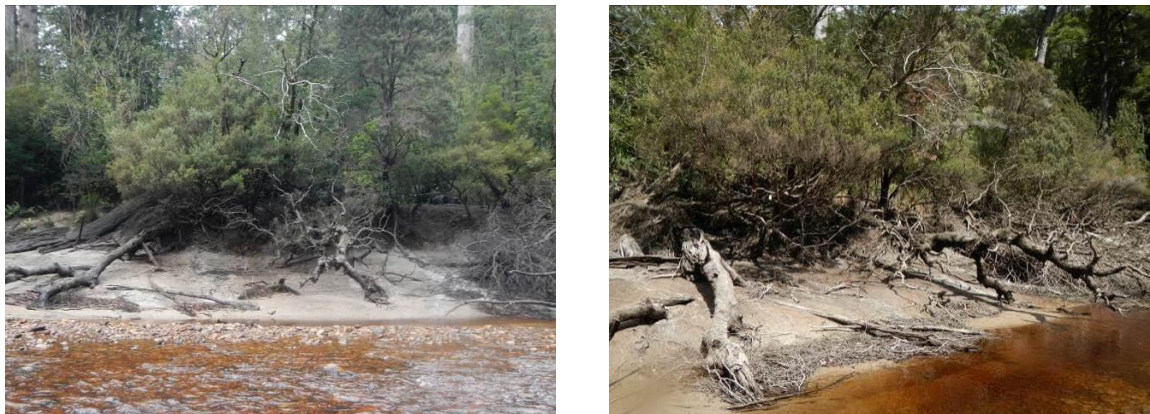
Figure 3-11: Site 1E, previous observation in autumn 2013 (left) showing presence of sand on bank face compared with the reporting period observation in spring 2013 (right) showing a reduction in sand.

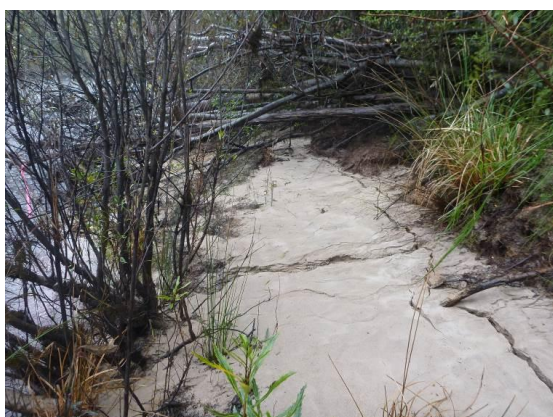
Figure 3-15: Tension cracks at erosion pin site 5A, autumn 2013.

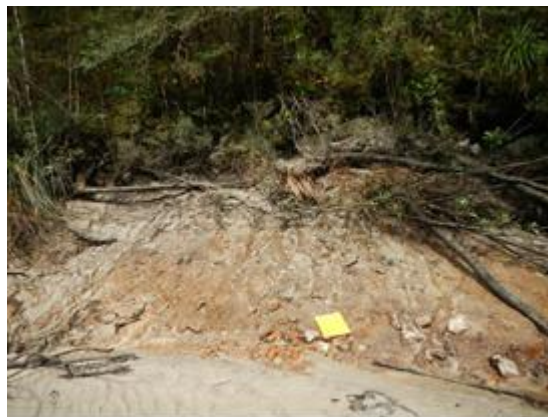
Figure 3-16: Sediment clasts expelled from bank due to high water pressure in saturated bank.

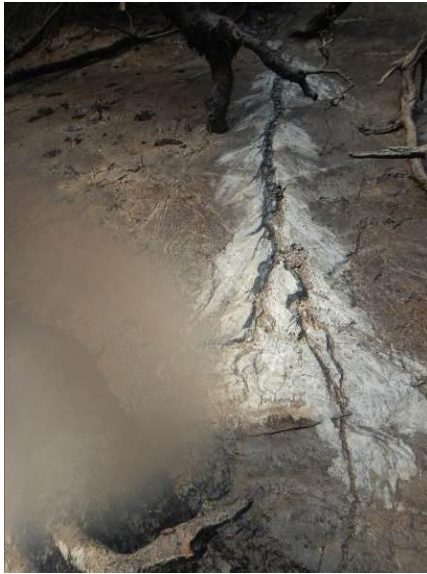
Figure 3-18: Rilling in zones 1 and 2: Water draining through sediment flow composed of white sands (photo cloudy due to moisture in camera).

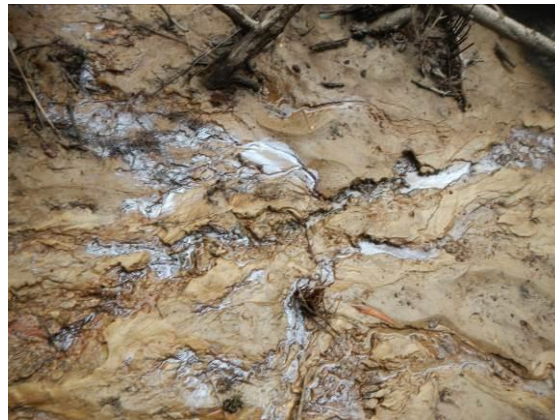
Figure 3-19: Rilling in zones 1 and 2: Rilling in zone 2 with organic oils present in drainage.

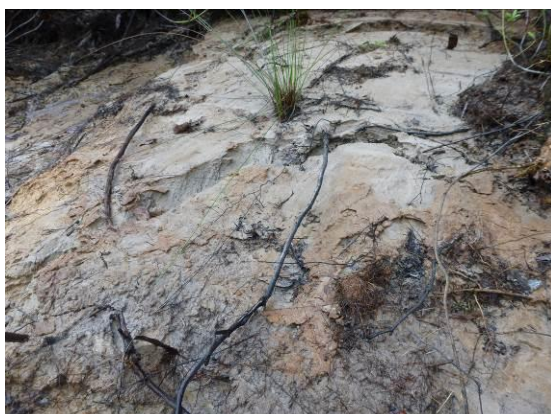
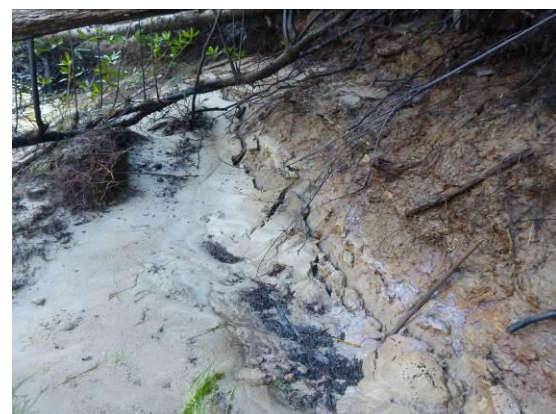
Other evidence of seepage processes included piping, tension cracks and bank slumping which were observed in all zones (Figure 3-20, Figure 3-21).

Figure 3-21: Tension cracks and bank slumping in zone 5.

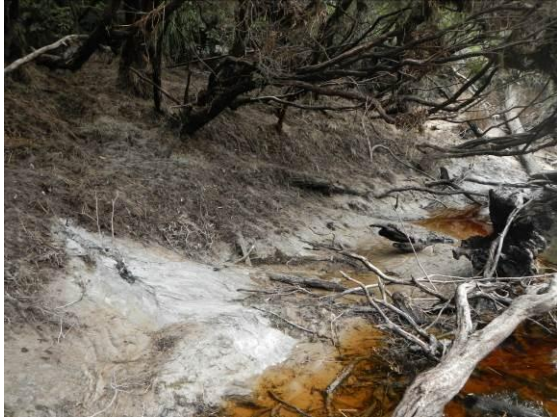
Figure 3-22: Sediment flows in zone 2 (erosion pin site 2H) on bank with tea trees.

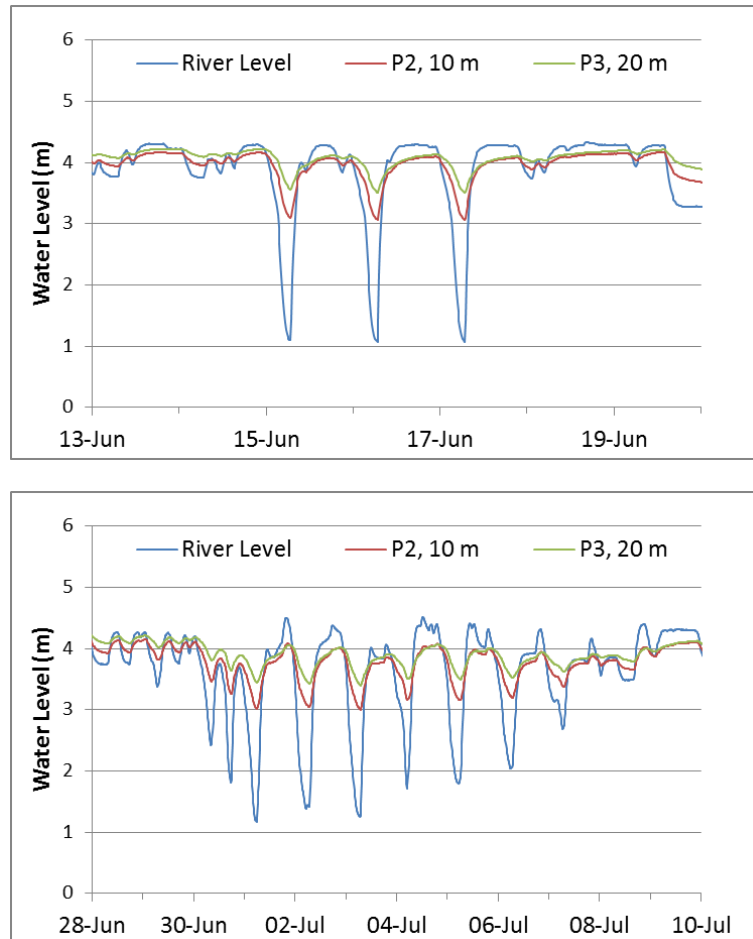
Figure 3-36: Piezometer results for 13 to 20 June, 2013 and 28 Jun 2013 to 10 Jul 2013 showing the piezometer results associated with peaking operations.

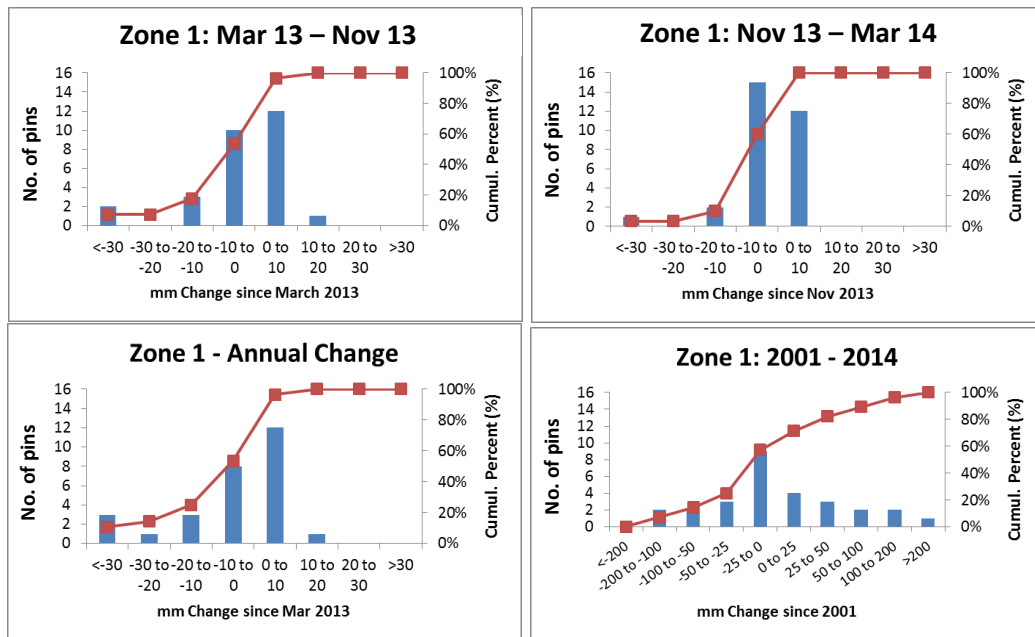
Figure 3-39: Erosion pin results for zone 1. Bins indicate changes to erosion pins relative to the monitoring period indicated in the title, with negative values indicating deposition (e.g. less of the pin is exposed), and positive values indicating erosion (e.g. more of the pin is exposed).
